Innovate UK project number	450033
Project lead and author	East Midlands Sustainable Construction iNet
Report date	2014
InnovateUK Evaluator	Unknown (Contact via www.bpe-specialists.org.uk)

Building sector	Location	Form of contract	Opened
Office	Daventry	Design and build	2011
Floor area (GIA)	Storeys	EPC / DEC 2013	BREEAM rating
4024 m ²	Single	B (26) / C (60)	Excellent

Intended as a practical demonstration of how to achieve high levels of energy and environmental performance in a cost-effective construction technique and procurement route.

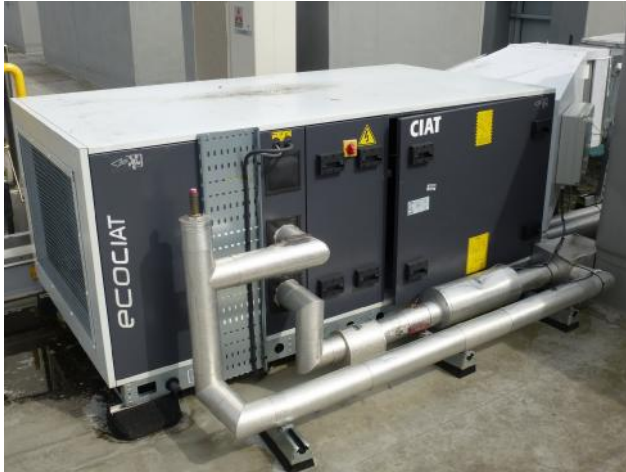
Roof-mounted exhaust-air heat pump (EAHP)

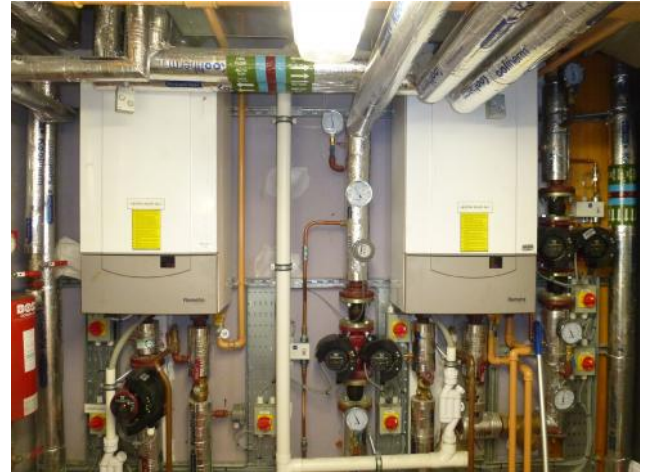
Identical boilers serving separate space heating and DHW circuits

The boiler serving the DHW calorifiers is controlled to maintain a 70°C flow temperature. Because the calorifiers are oversized for the quantity of hot water used the boiler cycles frequently. While it may be more efficient to maintain a pre-set minimum calorifier temperature rather than a primary flow temperature, concerns about Legionella meant the building maintenance team were reluctant to make changes. There have been problems with the water supply to the showers however they appear to have been resolved by the end of the evaluation project. The problems were believed to be caused by the failure of a PIR solenoid valve (intended to isolate water to showers to prevent them being left on).

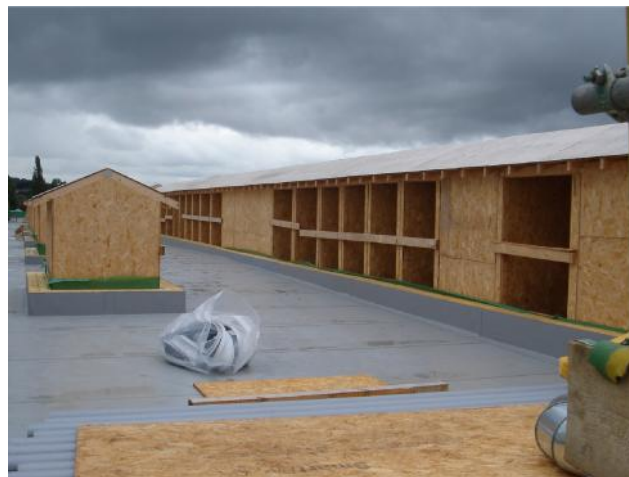
Roof level ventilation terminals during construction

Overheating has been exacerbated by the failure of several vent actuators which took some time to replace. During this time it was not possible to provide ventilation to the affected units. As a result some tenants were allowed to move into different office units. All of the faulty actuators were eventually replaced, however their long-term reliability is questionable.

Reports of cold offices may have been linked to problems with vent actuators that had failed to close tightly or had jammed in an open position. In addition, the offices adjacent to the unheated stairwells tend to be colder on average than the other offices. Problems with the heating system have occurred, particularly in December 2012 when the heating system failed to start automatically on several occasions. The reasons for this are unclear, however the optimum start control was found to be incorrectly configured and in one instance branch valves on the heating pipework had not been reopened after maintenance. Problems with a faulty pressurisation unit and pipework air-locks also interfered with the heating system. Some of these problems may have been due to incomplete commissioning and a lack of understanding of the heating control strategy by maintenance and building management staff.

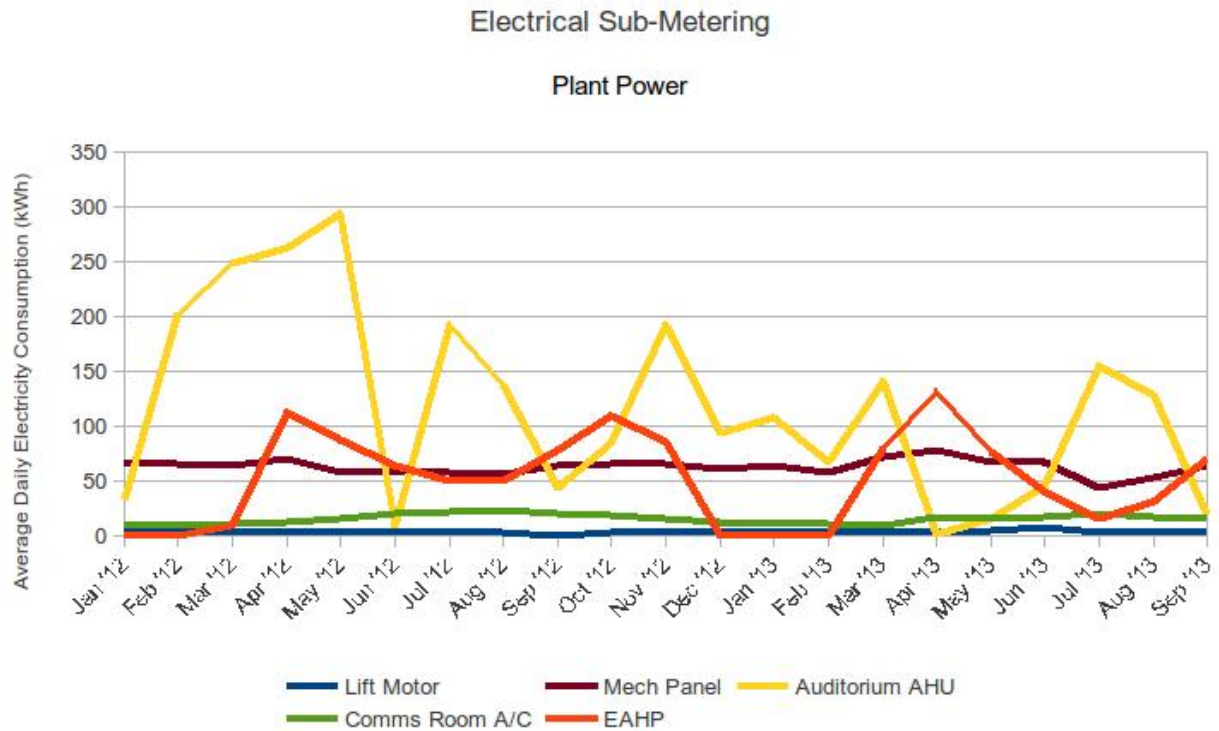
Fig. 13: Electrical sub-metering - Plant power

The variation in plant power consumption is due to the intermittent operation of the auditorium AHU and the exhaust air heat pump, the building's two largest single consumers of electricity. At the beginning of 2012, the auditorium AHU was left running permanently as it was otherwise unable to maintain the auditorium at a satisfactory temperature in cold weather. This was due to a compressor fault that has since been rectified. Even in warm weather the unit was frequently left running either accidentally or intentionally because the building operators were concerned that the unit, which had proved unreliable, will fail to restart if turned off. The extract air source heat pump was not fully operational during either of the two winters during the evaluation period. It was however in operation during spring and autumn seasons and surprisingly during the summer as well.

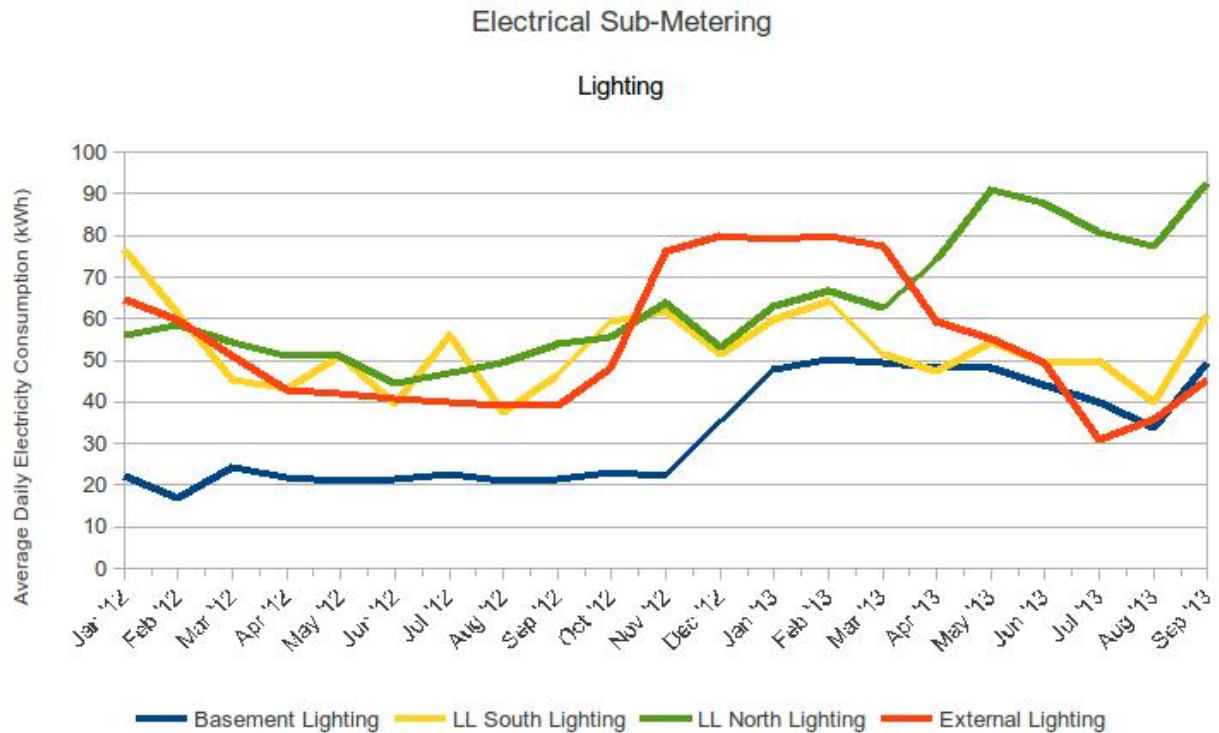
Fig. 14: Electrical sub-metering - Lighting

There is a seasonal variation in lighting electricity consumption, much of this is due to the external lighting, which operates on a time switch that is periodically adjusted to account for daylight availability. Landlord north lighting electricity consumption increased dramatically between March and May 2013. This may be due to the fire exit stairs being increasingly being used for general movement between office floors. The lighting in these stairwells is not controlled by PIR and is often left on overnight. The basement lighting electricity consumption has almost doubled since November 2012. This may be the result of manual adjustment or a failure of the PIR control and is due to be investigated.

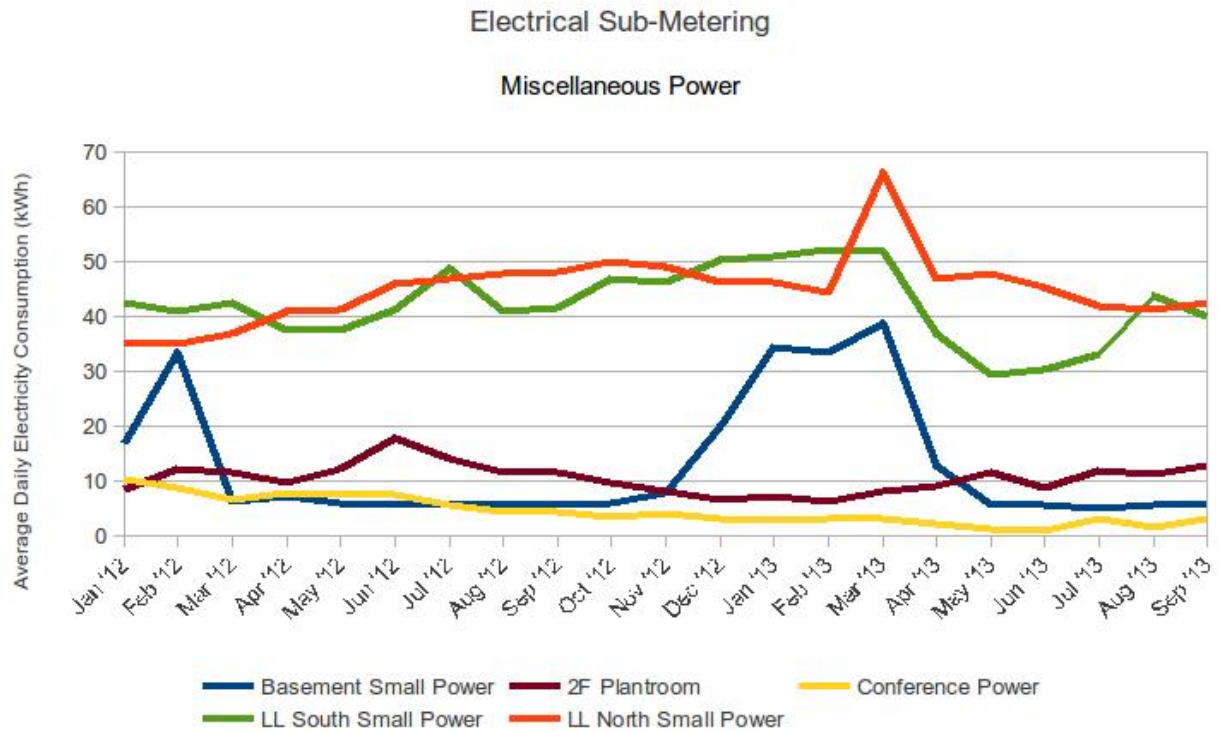
Fig. 16: Electrical sub-metering - Miscellaneous power

Fig. 16 shows the miscellaneous power consumption. Much of the variation in consumption is due to the operation of trace heating for pipework in the undercroft car park during cold weather. This is served from the basement small power distribution board. The consumption figure for the landlord north small power distribution board in March 2013 is artificially elevated due to the EAHP meter being offline (therefore it was not possible to subtract the EAHP consumption from the other loads on the distribution board). There was a significant reduction in the landlord south small-power consumption during spring 2013 however it was not possible to identify the reason.

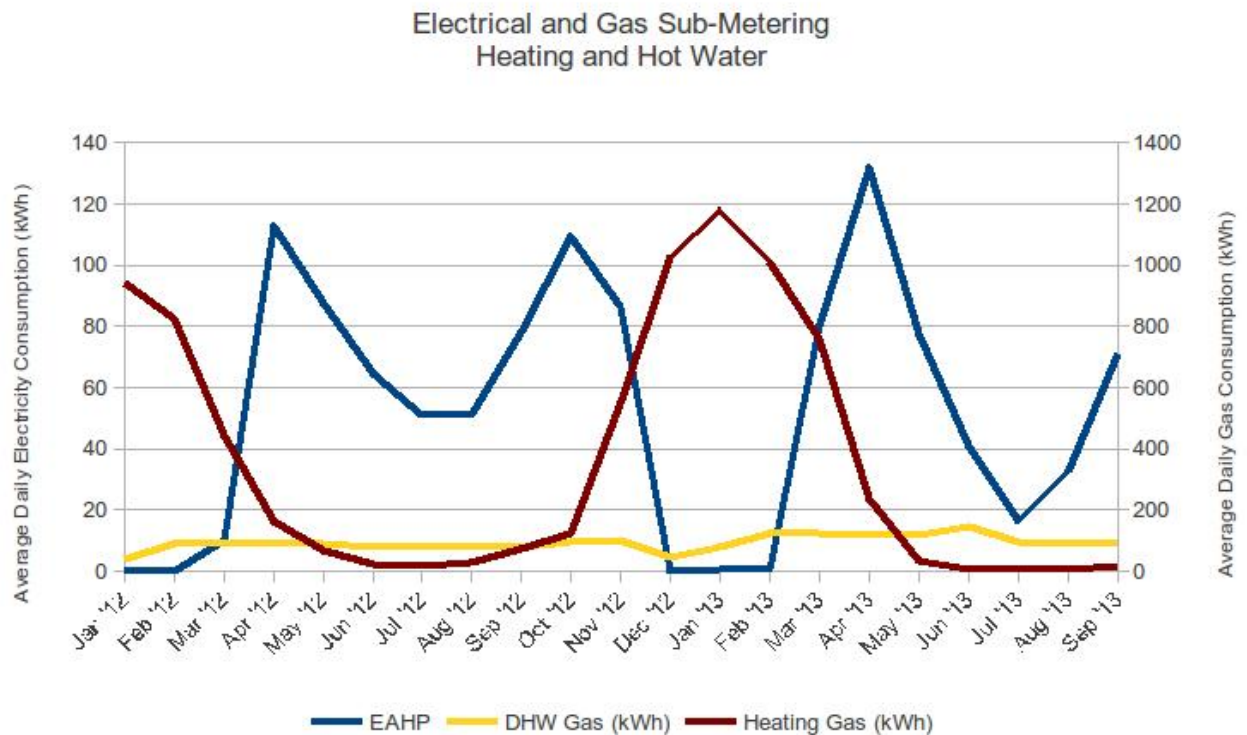
Fig. 17: Electrical and gas sub-metering - Heating and hot water

Fig. 17 shows the electricity and gas consumption used for heat generation. Gas consumption for domestic hot water is relatively stable. As the system appears to be oversized for the level of demand, most of the energy is used to maintain storage and circulation temperatures. Gas consumption for heating shows clear wintertime peaks, which are likely to have been exacerbated by the EAHP not contributing to the building's heating during both winters as well as the switch in December 2012 to 24/7 operation of heating (due partly to concern that it would fail to restart if left to BMS control). The EAHP continues to operate during the summer. This is probably unnecessary and is due to the high ambient temperature at which the heating plant is deactivated (currently 20°C). It must be noted that this comparison between kWh of gas and kWh of electricity does not take into account the greater efficiency of the heat pump, nor does it take into account the differences in primary energy or carbon intensity between gas and electricity. Fig. 18, below expresses the space heating system's gas and electricity consumption in terms of CO₂. Although the EAHP was intended to satisfy the majority of the building's heating demand the gas usage when the EAHP was operating is significant. This has been recently identified as a consequence of the boiler's flow temperature being set to 80°C, causing unnecessary cycling of both the boiler and EAHP. The flow temperature has been reduced to 60°C which should reduce cycling and allow the EAHP to operate more effectively. When designing and commissioning systems such as this that use a combination of heat sources, their compatibility (for example flow temperatures) must be considered.

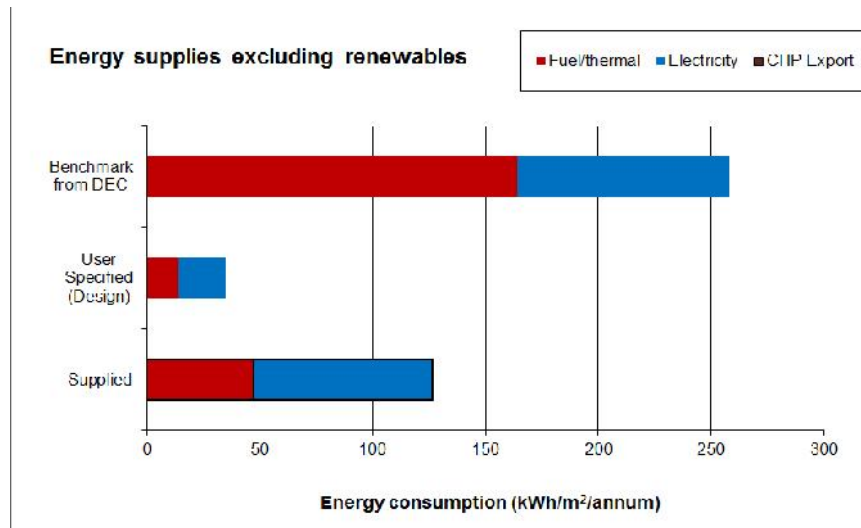
Fig 19: TM22 Simple assessment - Benchmark, design and in-use energy consumption

In terms of energy consumption, the building's electricity use is similar to the benchmark figure while the heating energy is significantly lower. The DEC benchmarks are intended to be representative of the whole building stock so a recently constructed building complying with recent building regulations would be expected to use significantly less energy heating provided it is operated reasonably well. Fig. 20 shows the same energy consumption in terms of CO₂ emissions, with a reduction in the percentage due to gas consumption on account of the lower CO₂ emissions conversion factor.

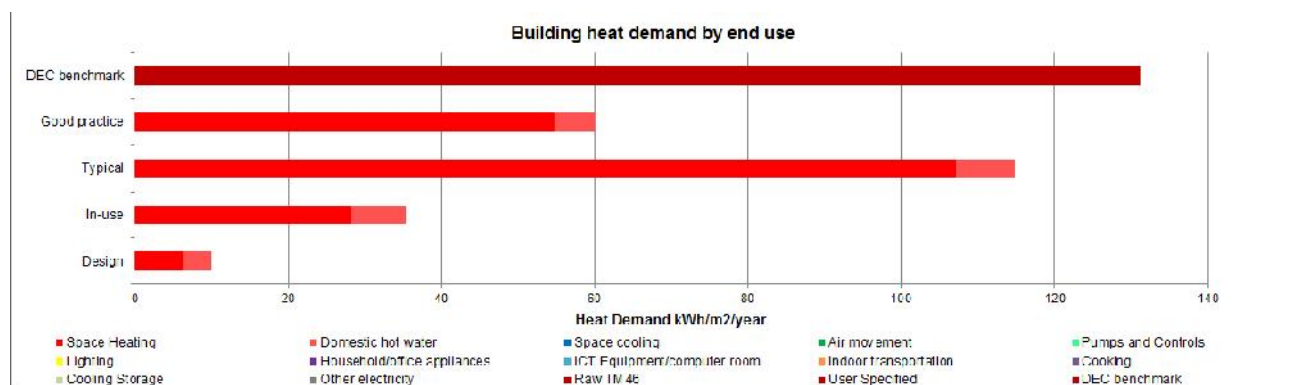
Fig. 21: TM22 Detailed assessment - Heat demand by end-use

In addition to the simple assessment shown above, the TM22 spreadsheet attempts to disaggregate energy consumption by end-use. This is based on a reconciliation of sub-meter readings against estimated consumption figures obtained from installed loads and adjustment factors for load duty, operating hours and seasonal variation. This is a different approach to the disaggregation described above so, although the resulting end-use figures are broadly similar, they will not correspond exactly. Fig. 21 shows a comparison of benchmark heat demand with design and in-use figures. As well as the DEC benchmark, the detailed assessment includes a comparison with office benchmarks from Energy Efficiency Consumption Guide 19 (ECON19). The benchmarks given are for naturally ventilated cellular offices. Because the graph expresses heat demand rather than energy consumption an average thermal efficiency of 75% is applied to the benchmark figures. A similar figure has been applied to the design and in-use space heating and hot water energy consumption. In terms of heat demand the domestic water is similar to the typical figure however the space heating demand would appear to be less than both typical and good practice benchmarks. In this building however, space heating demand is intended to be met primarily by the air source heat pump, which is an electrical load rather than a thermal fuel load.

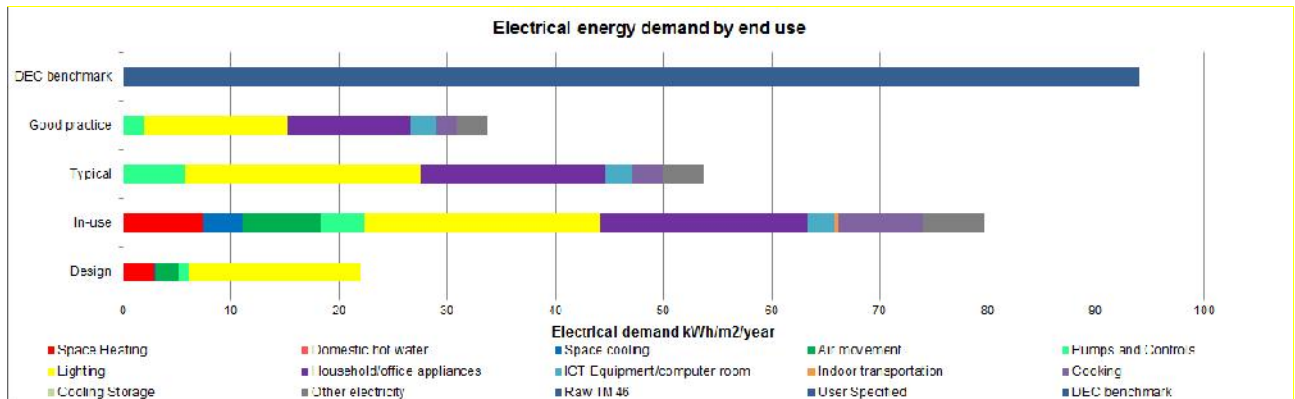
Fig. 22: TM22 Detailed assessment - Electricity demand by end-use

Fig. 22 shows a comparison of benchmark electricity demand with design and in-use figures. The design figures clearly don't include any unregulated loads such as offices appliances and catering. The in-use figures are larger than both the good practice and typical benchmarks. This is due partly to the inclusion of heating energy consumption, which is absent from the benchmarks because it is assumed to be provided by thermal fuel, and cooling and air movement energy consumption, due to the presence of a mixed-mode ventilation system and air conditioning in the auditorium, meeting and comms rooms.

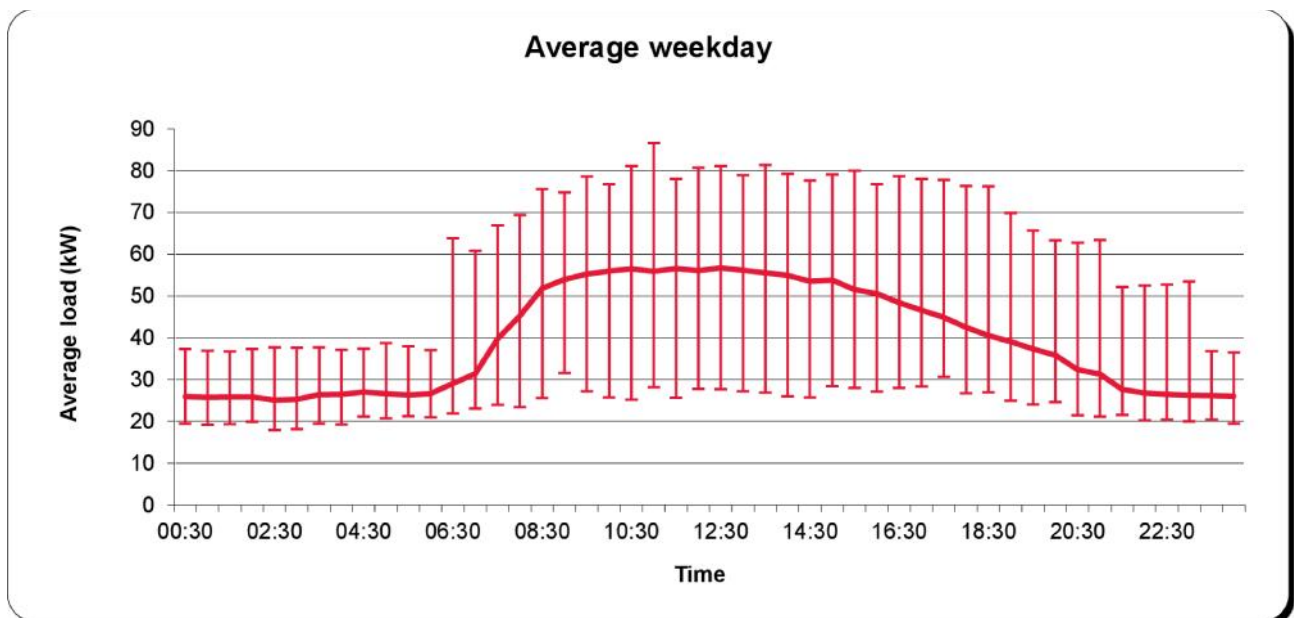
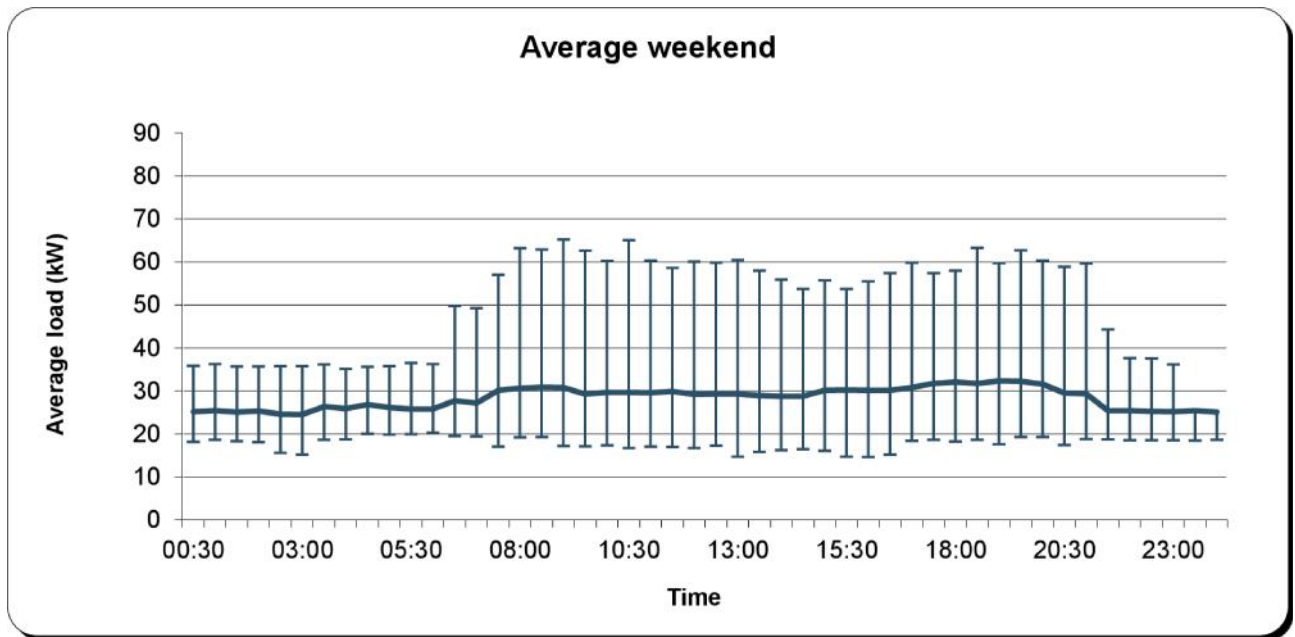
The following graphs, Figs. 23 and 24, show average daily electrical load profiles obtained by processing the supplier's half-hourly consumption data with the TM22 half-hour data analysis module. Both profiles show a large variation in half-hourly loads from about 8am to 10pm. Outside of these hours there is less variation about what appears to be a baseline load of 25 kW, which doesn't change at weekends. This average baseline load will be made up of a variety of end-uses including external lighting, internal lighting left on overnight, mechanical plant such as the heat pump that may have been running continuously, kitchen fridges and freezers, as well as IT equipment that run continuously. Average weekday consumption increases between about 7am and 9am, corresponding to the beginning of the working day. Consumption begins to tail off in the afternoon. The rate at which consumption increases is greater than the rate at which it tails off. This is probably due to there being greater variation in occupant leaving times than arrival times. There is a slight increase in average consumption from 8am to 10pm on weekends, which is due to occasional weekend use of the building.
