Delivery and performance of a low-energy ventilation and cooling strategy

C. Alan Short^{1,2}, Malcolm Cook³ and Kevin J. Lomas³

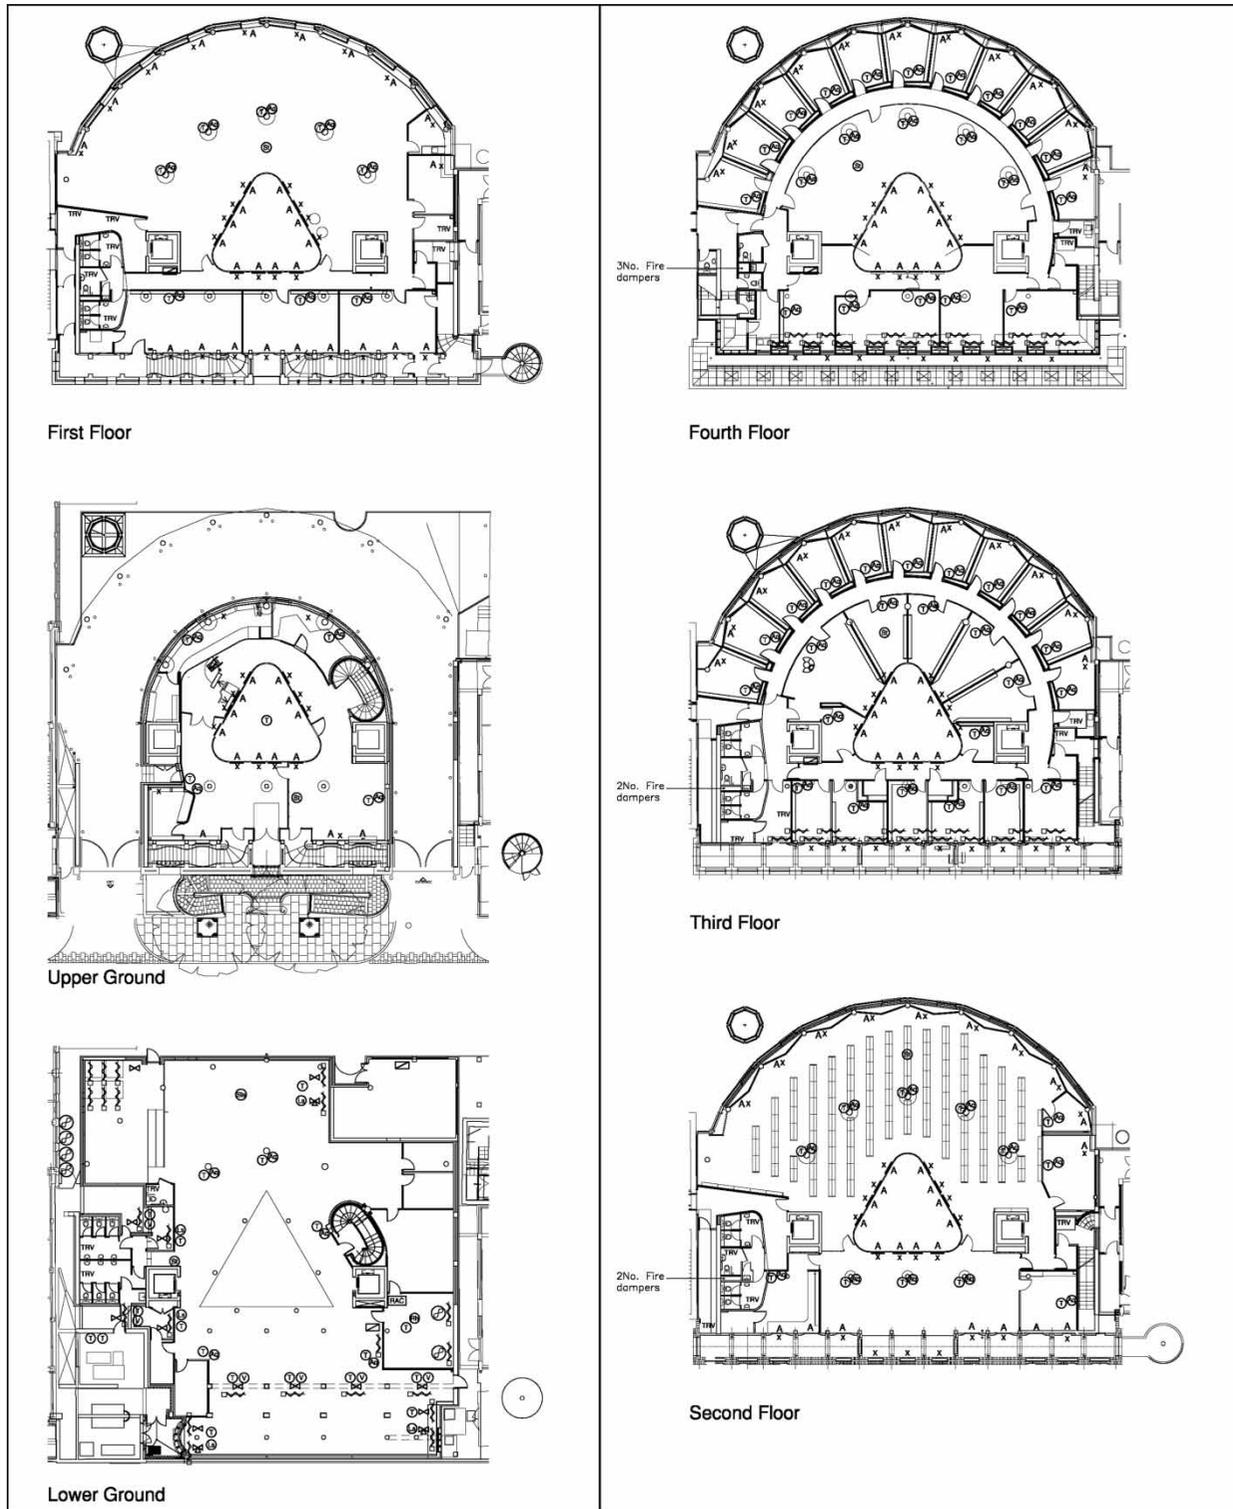
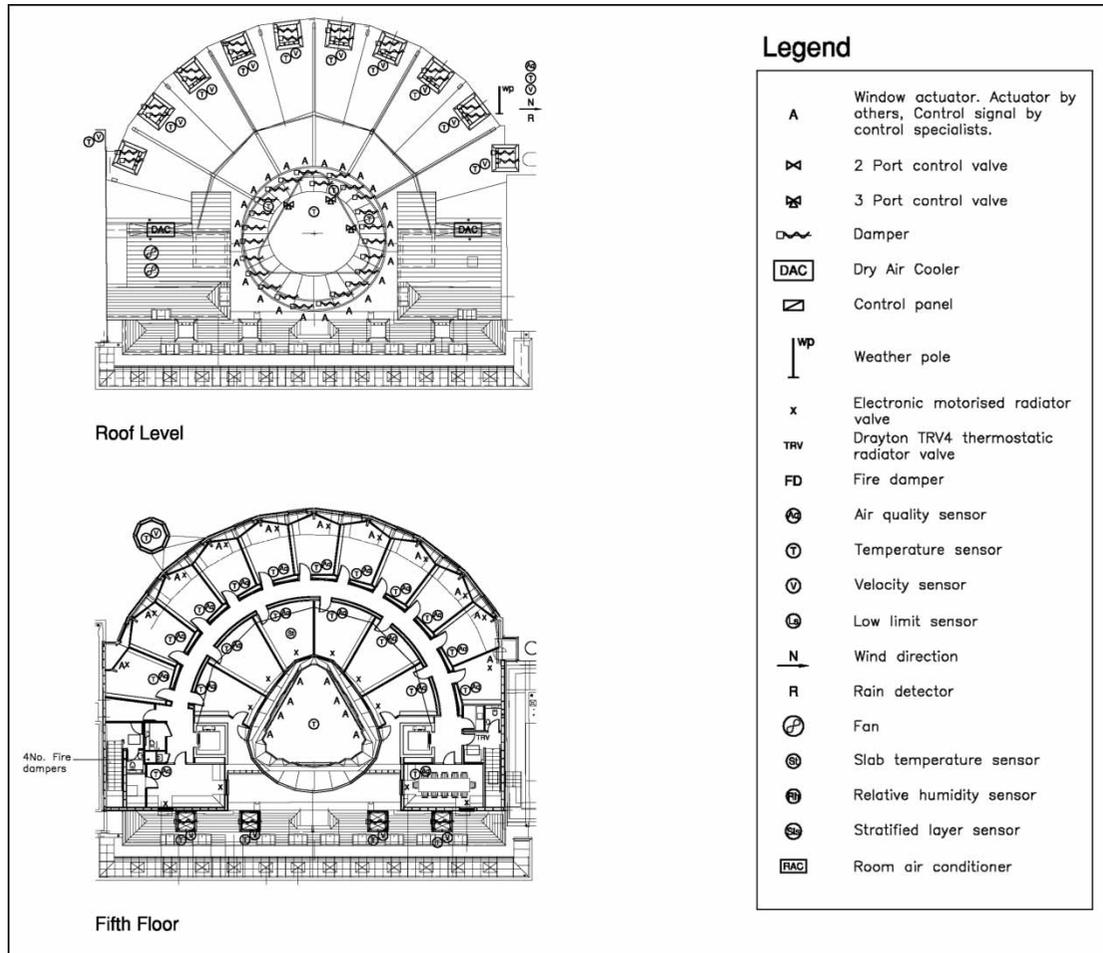
Figure 9 Layout of the BMS sensors installed in the building

The BMS sensors performed as intended. No significant failures were identified, but the BMS software was subject to regular close down, interference from incompatible software installed within the system, and external network attack. Low-level, elementary installation failures affected the performance of the heating, whilst low-level construction defects compromised the air-tightness of critical air supply and exhaust plena. However, throughout the 20-month post-completion period recorded here, the failure of

simple motorized window actuators both physically and in their interface with the controls was detected continuously until the final few weeks. The design included 160 controls-actuated windows and 120

controlled dampers. Monitoring records, considered in the next section (Table 1), show clearly how their apparently random failure across the geography of the seven-storey building impaired its performance.
