ENGLISH HERITAGE RESEARCH TRANSACTIONS

Volume 1

April 1998

The underside corrosion of lead roofs and its prevention

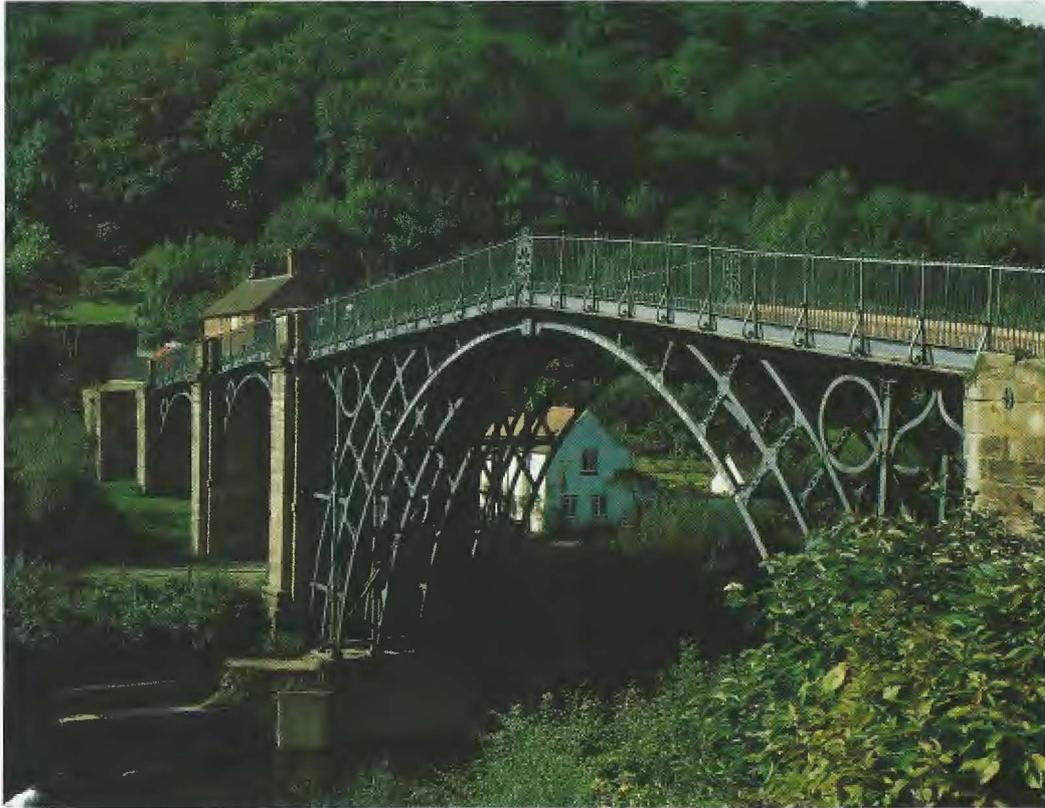
Plate 1. Abraham Darby's Iron Bridge at Coalbrookdale (1777–81) is a notable early example of the structural use of cast iron. From such precedents, cast iron warehouses, mills and factories were developed, many designed to be of fire proof construction.
