Orchard Learning Resources Centre

The Orchard Learning Resources Centre at the University of Birmingham attempted to develop the genre for low energy, naturally ventilated academic buildings. How did the design and construction team get on?

BY THE PROBE TEAM

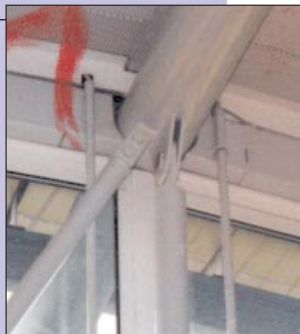
- 4. Air leakage** The poor results from the pressure test (of 31.5 m³/m²/h) demonstrates that merely registering concern with a contractor is not enough. The only surefire way to achieve an airtightness standard is to include in the main contract a requirement to demonstrate compliance by means of a pressure test. That said, the design team needs to provide air tight construction details for the contractor to follow, and to provide effective site supervision until the principles become second nature for builders.

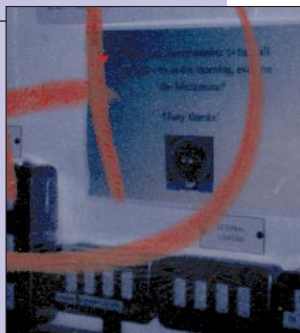
- 5. Lighting control** The design team tried hard to create an efficient light switching system without going to the cost and complexity of automatic daylight or occupant sensing. To date the outcome has been an extreme default to on. This is less a failure of design and more a reflection of the general lack of occupant interest in saving energy (the 10 m distance from reception desk to security room is proving too great). The alternative – technically elegant controls – may have sex appeal, but they often demonstrate fragility.

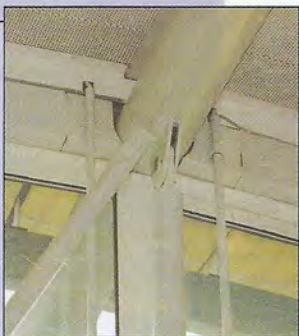
- 4. Air leakage** The poor results from the pressure test (of 31.9 m³/m²/h) demonstrates that merely registering concern with a contractor is not enough. The only surefire way to achieve an airtightness standard is to include in the main contract a requirement to demonstrate compliance by means of a pressure test. That said, the design team needs to provide air tight construction details for the contractor to follow, and effective site supervision will be necessary until the principles become second nature for builders.

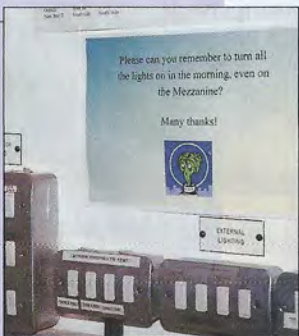
- 5. Lighting control** The design team tried hard to create an efficient light switching system without going to the cost and complexity of automatic daylight or occupant sensing. To date the outcome has been an extreme default to on. This is less a failure of design and more a reflection of the general lack of occupant interest in saving energy (the 10 m distance from reception desk to security room is proving too great). The alternative – technically elegant controls – may have sex appeal, but they often demonstrate fragility.
