BY THE PROBE TEAM

PROBE

## 16: Marston Book Services

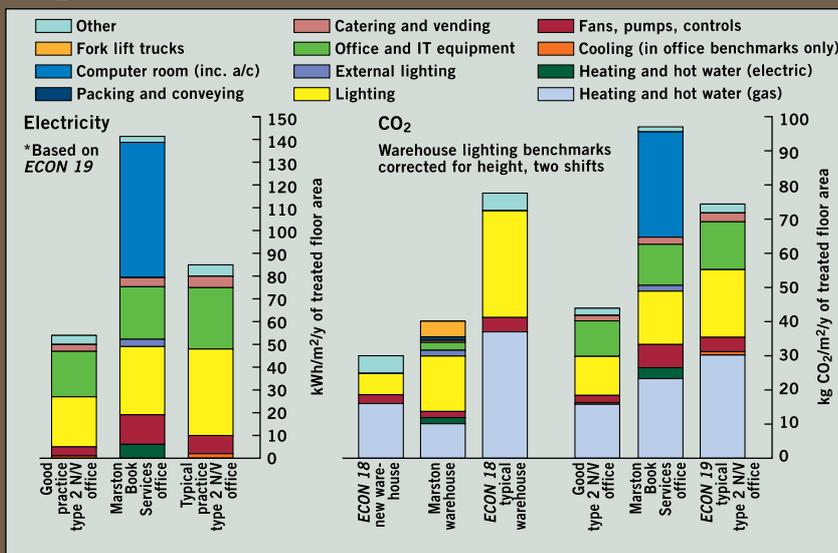
FIGURE 1: End-use energy breakdown at Marston Book Services. Conversion factors are gas: 0.2 kg CO<sub>2</sub>/kWh and electricity: 0.52 kg CO<sub>2</sub>/kWh. All electrical energy consumption is based on 1997 data. Although not shown, the electrical consumption of the warehouse (42 kWh/m<sup>2</sup> of footprint area, or 31 kWh/m<sup>2</sup> including the mezzanine) can be considered close to the 'improved' benchmark in *ECON Guide 18*.

At 6 kWh/m<sup>2</sup>/y of treated floor area, electricity for office hot water is close to the typical benchmark<sup>3</sup> of 7 kWh/m<sup>2</sup> where water heating is electric (figure 1).

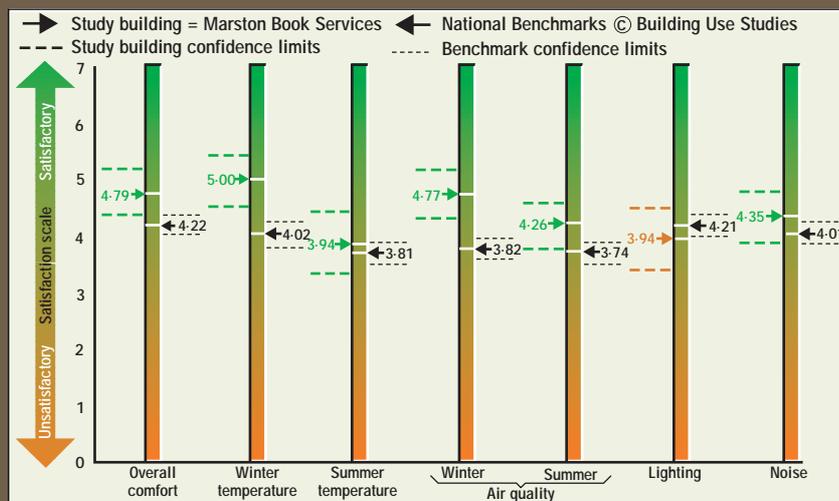
Building Use Studies (BUS) carried out a survey of all 55 office staff in 1997 (figures 2 and 3). 32% of the staff are male, compared with a 52% dataset average. 62% say they have window seats (norm: 64%). 47% are under 30 (norm: 35%). Almost all work standard hours, mostly at vds for six hours or more each day.

The overall impression of the lighting was slightly worse than average. Occupants perceived too little natural light (though slightly

FIGURE 2: Overall satisfaction with comfort conditions at Marston Book Services.

more than average). Anecdotal comments suggest that this perception largely reflects frustration at the blinds having to be closed and the electric lighting used if the sun or sky is too bright.

The reported glare from sun and sky is disappointing in view of the care devoted to the window system. This seems to be due to diagonal sunshine coming past the ends of the light shelves and bright spots on the translucent blinds in bright sunshine. There are no blinds on the north facade, but bright skies can still cause problems with contrast glare and reflections in computer screens.

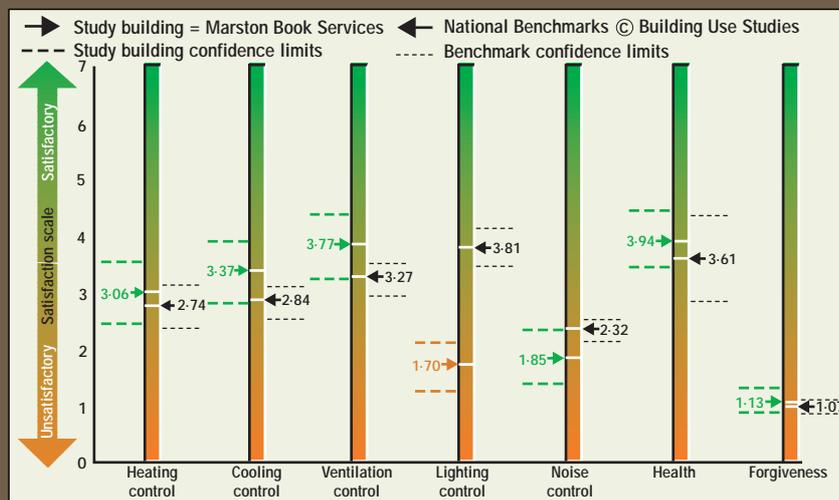
FIGURE 3: Occupant satisfaction with the building's health, management and control strategies.
