BY THE PROBE TEAM

18: Portland Building

The Portland Building is the fifth educational building to be surveyed by the PROBE Team, and the last in the current PROBE series of building investigations.

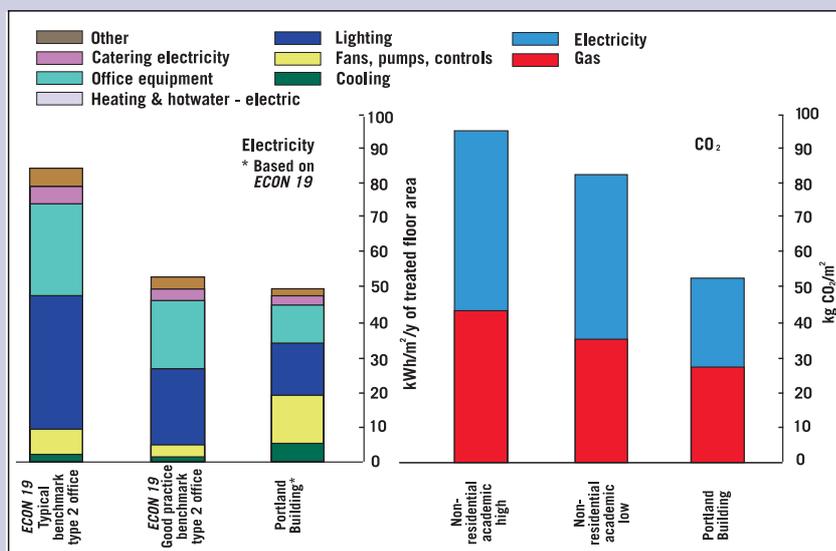
FIGURE 1: End-use energy breakdown at the Portland Building. The conversion factors are: gas – 0.2 kg CO₂/kWh and electricity – 0.52 kg CO₂/kWh. *Electricity use at the Portland Building was calculated from three weeks of monitoring of half-hourly data.

Reasons for consumption above *ECON 19's* 'good practice' benchmark of 79 kWh/m² include air infiltration and, according to the occupant survey, possibly warmer than neces-

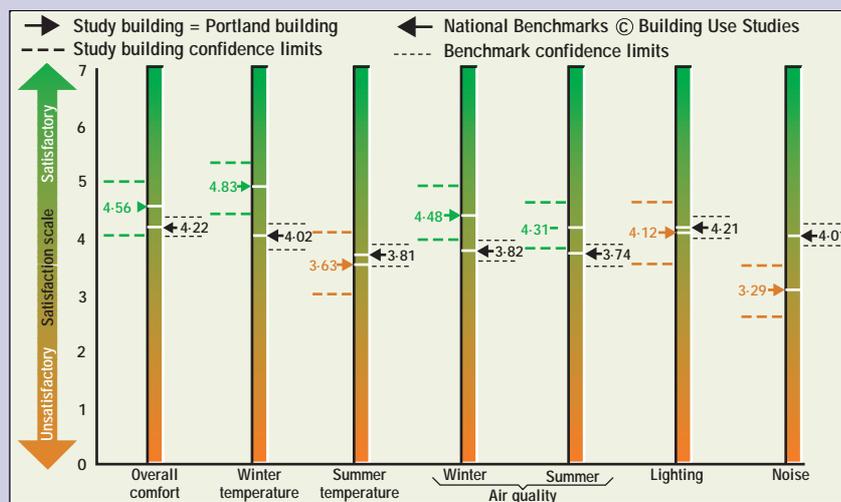
Questionnaires were completed by 46 staff with permanent workstations. On average they rate the building well as an all-rounder, coming just within the top 20% of the reference dataset, though people (particularly the archi-

FIGURE 2: Overall satisfaction with comfort conditions at the Portland Building.

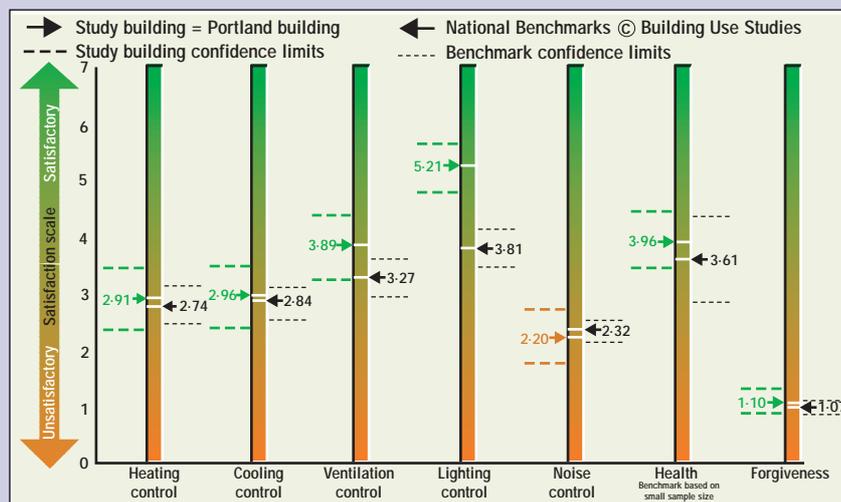
FIGURE 3: Occupant satisfaction with the building's health, management and control strategies.

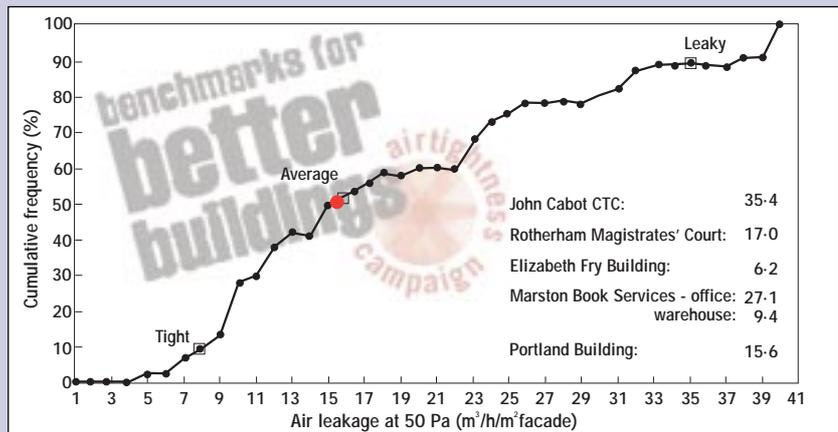
FIGURE 4: The air leakage data for the Portland Building, plotted on the BRE/BSRIA database.

The air leakage index (or Q-value) for the Portland Building was calculated to be 15.6 m³/h/m² of envelope area at a reference pressure of 50 Pa. This indicates that the building performs about average on the joint BRE/BSRIA database (figure 4). In the BRE's opinion, a tight non-domestic

building would have a Q-value of 7.5 of envelope area at a pressure differential of 50 Pa. A leaky building on the BRE/BSRIA databasewould exhibit a Q-value of 34.

The air leakage audit showed that the roof/wall junctions on the third floor were very leaky. The junctions between the RSJs and timber beams were also found to be very leaky, with large gaps visible. Air was detected coming from the ventilation towers, indicating that these structures were not airtight.
