Just how low can we go?

While we fret about making new homes zero-carbon, it's easy to forget about the refurbishment market. **James Parker** visits 89 Culford Road in London to see what can be done to make existing dwellings extreme low carbon

BSRIA MODEL PROJECT

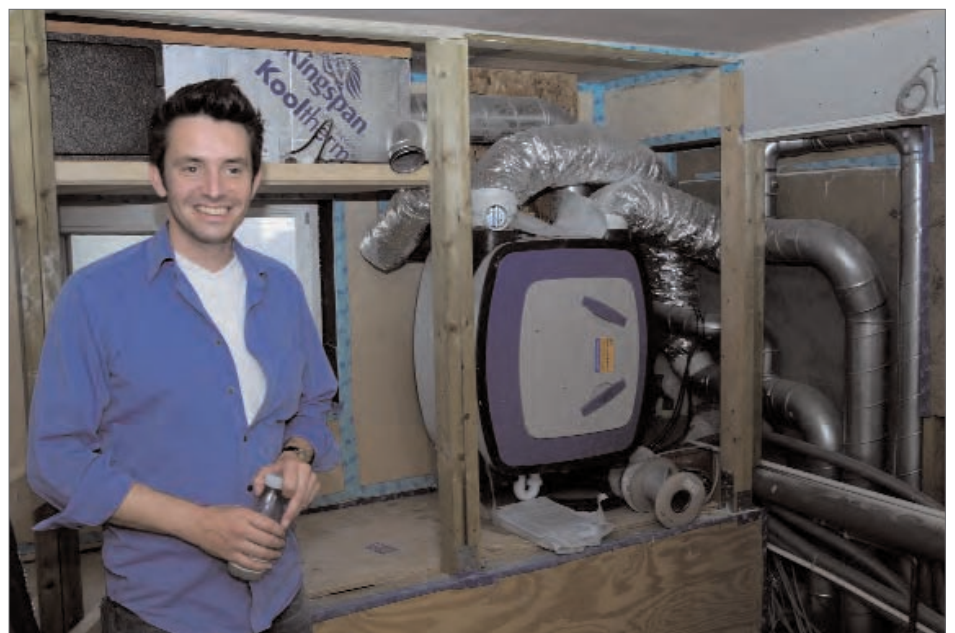
Above: Architect Robert Prewett with 89 Culford Road's Itho HRU Eco 4 mechanical ventilation with heat recovery unit. This is said to possess a reclaim efficiency of up to 91 per cent, predicted to give a cut of 4264 CO₂ kg per annum compared to the dwelling's original heat requirements.

The high level of airtightness therefore justified the use of a mechanical ventilation and heat recovery unit (mvhr). The product chosen was the Itho HRU Eco 4.

This plant, installed on the top floor adjacent to what will be Bronwen's home office, will suck out stale air from the bathroom and kitchen, transferring

the heat to outside supply air, then distribute it throughout the house via a system of flexible ducts run down an interstitial gap adjacent to the party wall.

As the mvhr manufacturer claims an heat reclaim efficiency of up to 91 per cent, the Cohens accepted the fan power penalty as the mvhr should considerably reduce the dwelling's heating requirements. (See tables 1-3 for energy savings and paybacks.)

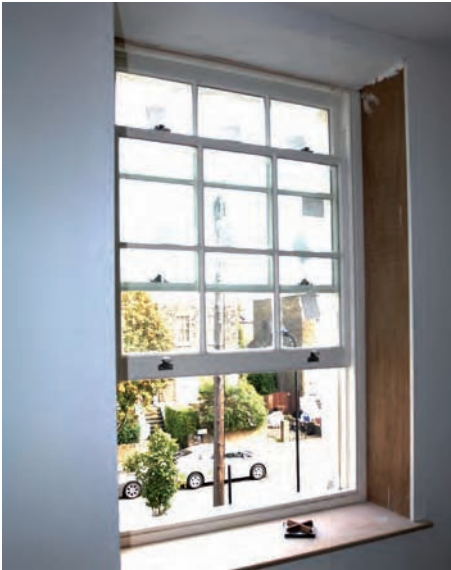
The micro double-glazed windows retained their sash features, albeit replaced with new frames with improved seals (four draught seals per sash) to help with airtightness. This gives the front of the house a virtually original appearance

had to have very good seals and very low U-values. This was not easy to fit into a façade in a strict conservation zone. The solution was micro (or slim) double-glazing. These have a small argon-filled gap of only 4 mm. This gave a glazing profile very close to the original. Heat retention is improved with a low-e coating that reflects heat back into the room.

The front windows also kept the sash opening, albeit reproduced with improved seals (four draught seals per sash) to help with the airtightness. This gives the front of the house a virtually original appearance. The rear of the house, without the strict levels of conservation to observe, is equipped with a more traditional low energy window: triple glazing with double edge seals.

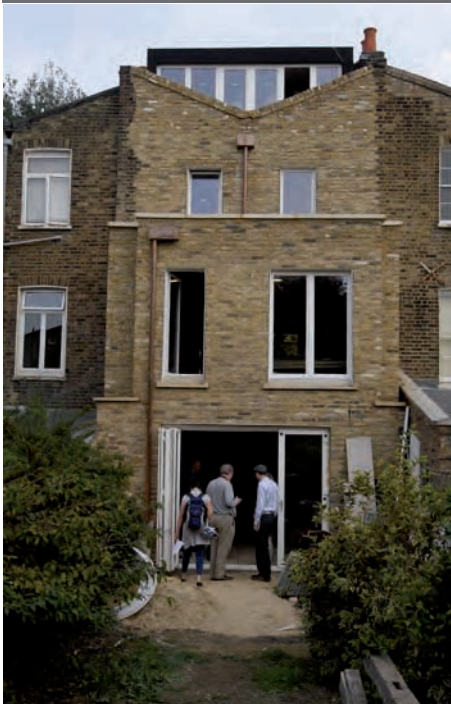
The original back wall was completely removed and rebuilt with reused brick to minimise the environmental damage and 200 mm of insulation to improve its thermal performance. Rainwater from the roof is captured by copper drains on this elevation. Standard triple-glazed windows were acceptable as the rear elevation was not governed by local authority conservation rules

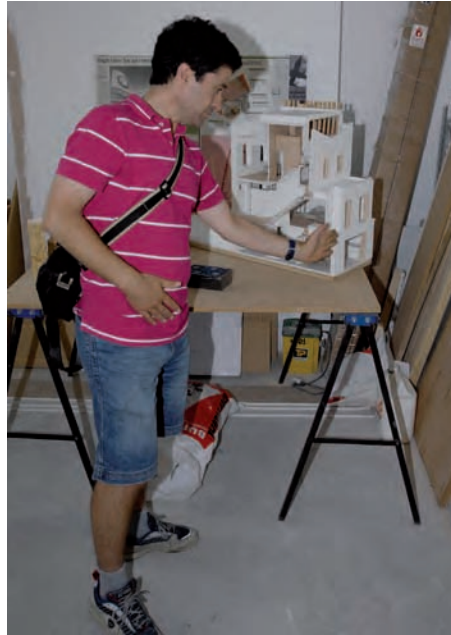
Left: Robert Cohen with a model of 89 Culford Road, showing clearly how the new structure extends out beyond the original building boundary. One lesson learned is never to underestimate how much living space can be lost through installing deep thicknesses of internal thermal insulation - on party walls as well as front and rear elevations. Interstitial space is also required for ducts that link the mechanical ventilation system with bathrooms and the kitchen.

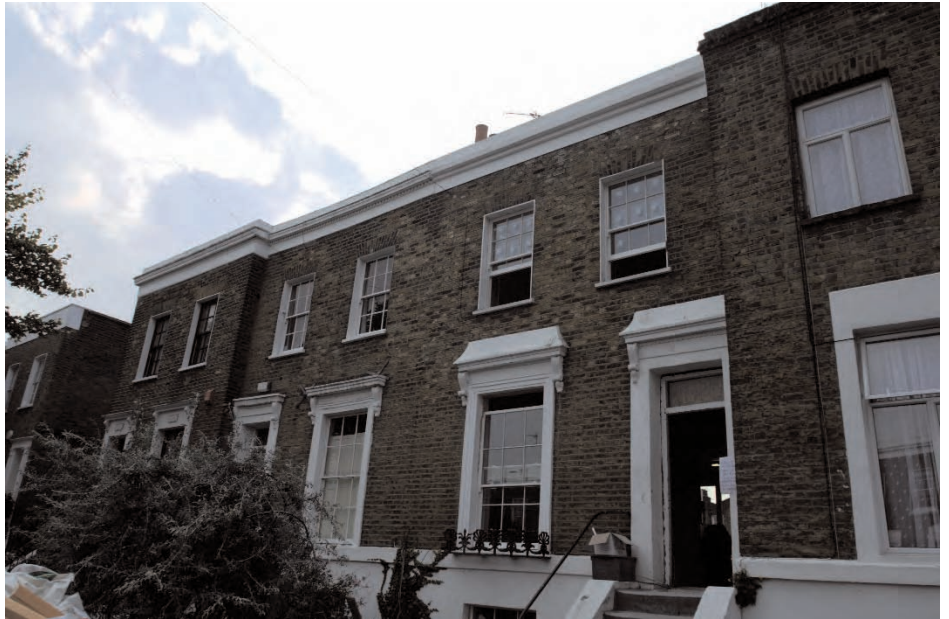
Right: Spot the difference. Despite being a conservation area, the house next to 89 Culford Road has standard double-glazed units, whereas Robert Cohen retained the original style sash windows. Extreme low carbon refurbishment doesn't need to look radically different, although what is visible here was just about the only part of the house retained. The entire rear wall and all suspended floors were replaced.

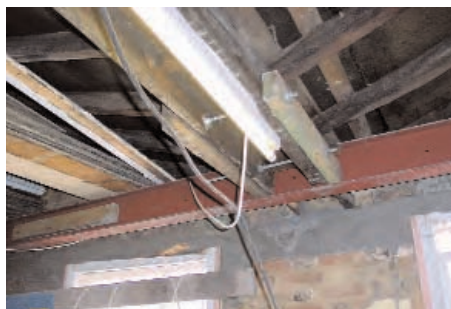
Above: Roof timbers were retained where possible.

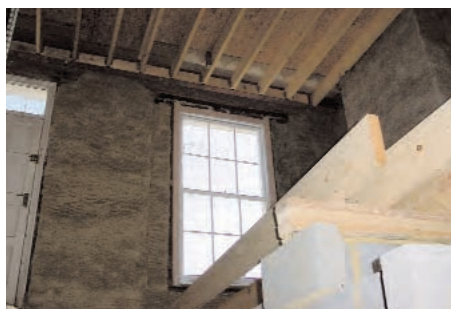
Above: The front wall rendered and awaiting insulation.

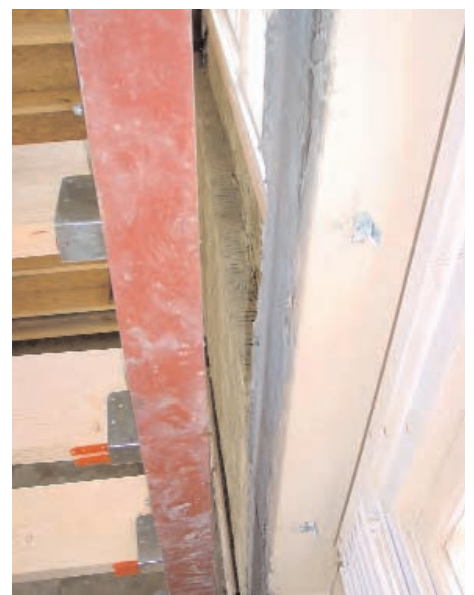
Above: An internal frame was constructed inside the front wall to support rebuilt floors and also to eliminate thermal bridges. The gap between the existing façade and the frame is filled with 140 mm of insulation.

While the front elevation was kept original, an internal frame was constructed inside the front wall to support rebuilt floors and also to eliminate thermal bridges. The gap between the existing façade and the internal frame is filled with 140 mm of insulation, with a small ventilated space between the façade and the insulation. Extra insulation was also added to the floor (100 mm) and to the roof (180 mm).
