BREATH OF FRESH AIR

The design team behind the refurbishment of the NFU Mutual's HQ - a pioneering building in its time - was determined not to resort to airconditioning, despite popular demand. Stephen Kennett finds out how

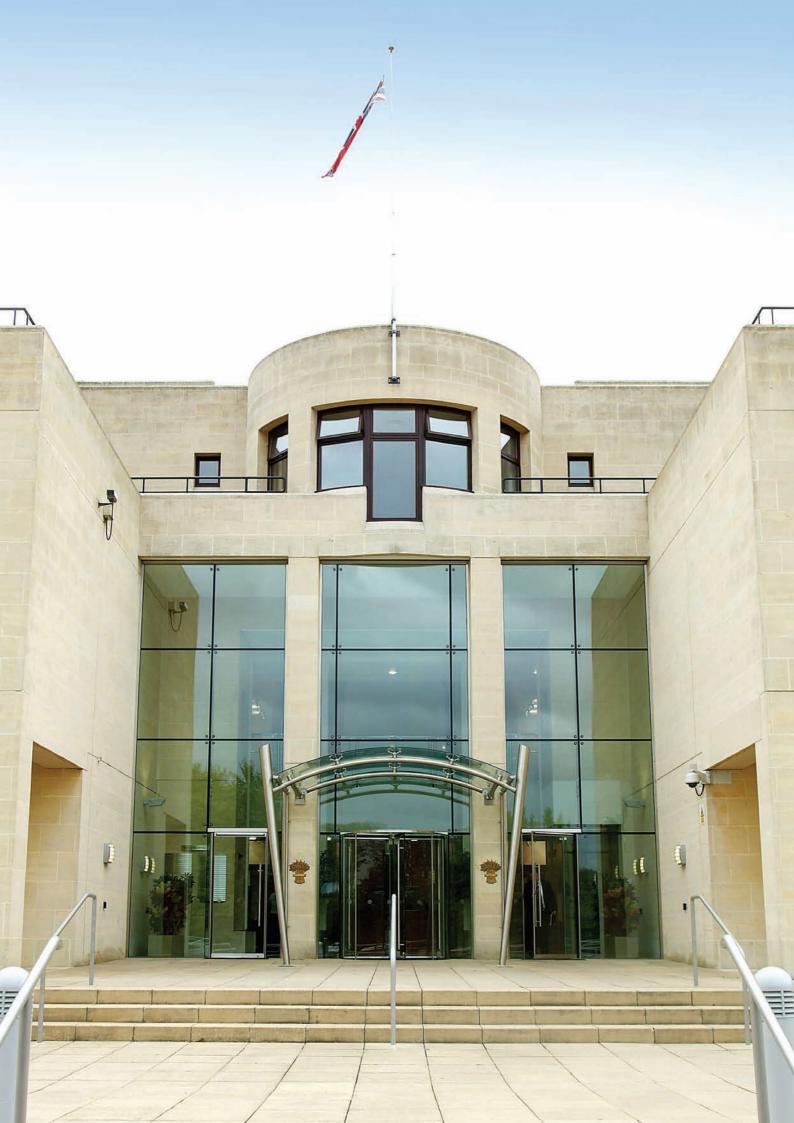
LEFT: Sand blasting cleaned the facade of the NFUM HQ, which also got a new entrance and reception area. It was with a certain amount of trepidation that HBS Consulting Engineers approached the challenge of refurbishing the National Farmers' Union Mutual Insurance Company's HQ – after all, this was a cutting-edge building in its day. Designed as a corporate head office, it shunned air conditioning for mixed-mode ventilation, employed a heavyweight structure and solar controls to limit summer temperatures and sought to maximise daylighting while achieving an annual energy use target that would put most naturally ventilated offices to shame. And that was back in 1979.

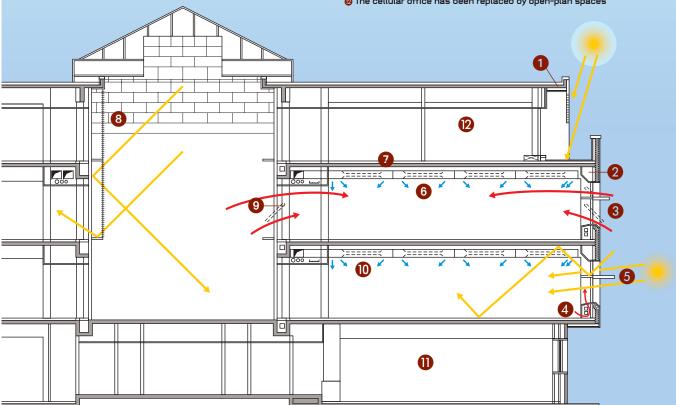
At the cutting edge of building services engineering in 1979: the original environmental design

8 External electrical solar control blinds in exposed positions

- Fully refurbisjed multi-service beams now incorporate new
- T5 fittings, lighting controls and smoke detectors
- () The kitchen and restaurant have been relocated and the
- space converted into more offices () The cellular office has been replaced by open-plan spaces

In summer, the windows were opened manually to provide cross ventilation. When the weather became very hot this could be boosted by the mechanical ventilation system by up to four air changes per hour with air being purposely 'blasted down' onto people to increase the psychological cooling effect.
