This document contains a Building Performance Evaluation report from the £8 million Building Performance Evaluation research programme funded by the Department of Business Innovation and Skills between 2010 and 2015. The report was originally published by InnovateUK and made available for public use via the building data exchange website hosted by InnovateUK until 2019. This website is now hosting the BPE reports as a research archive. As such, no support or further information on the reports are available from the host. However, further information may be available from the original InnovateUK project evaluator using the link below<sup>1</sup>.

| <b>InnovateUK project number</b> | 450049 Related study: 450023 (Phase 1) |
| <b>Project author</b> | UCL and RMIT for bere:architects |

| Single | London (Camden) | Detached 2-storey house | 2010 |

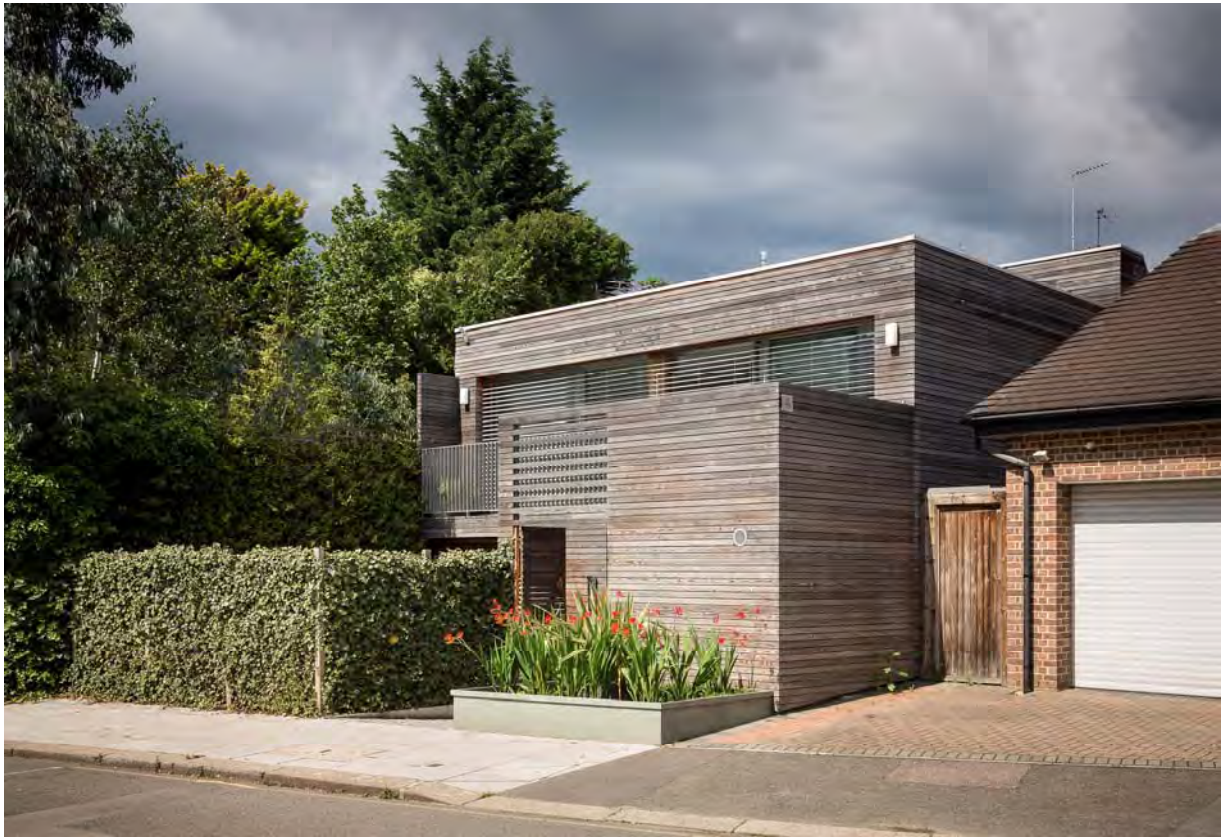
**Figure 1-2b. South facing street elevation of the Camden Passive House, with living room on the first floor and bedrooms on the ground floor. Cladding is Austrian larch.**

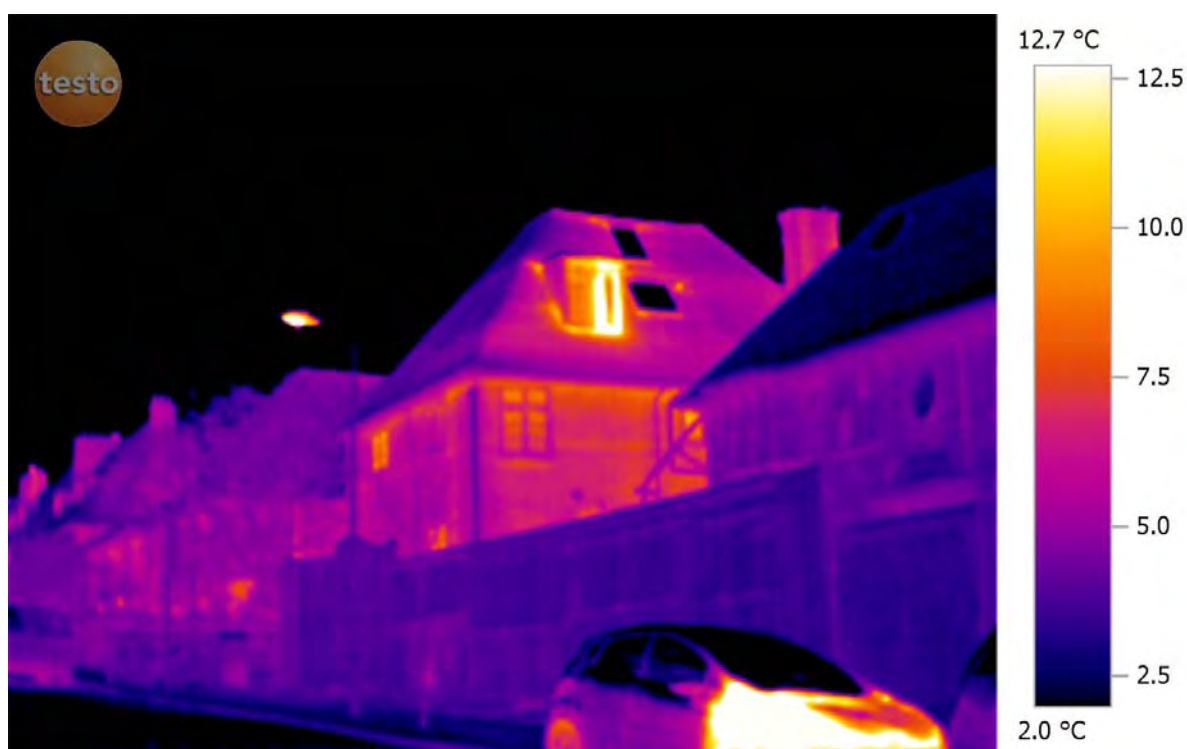
**Figure 2-1.** This thermal imaging picture shows significant heat leakage from a house in the same street as the Camden Passive House. Problem houses typically feature un-insulated solid brick walls, poorly insulated roofs and open windows.

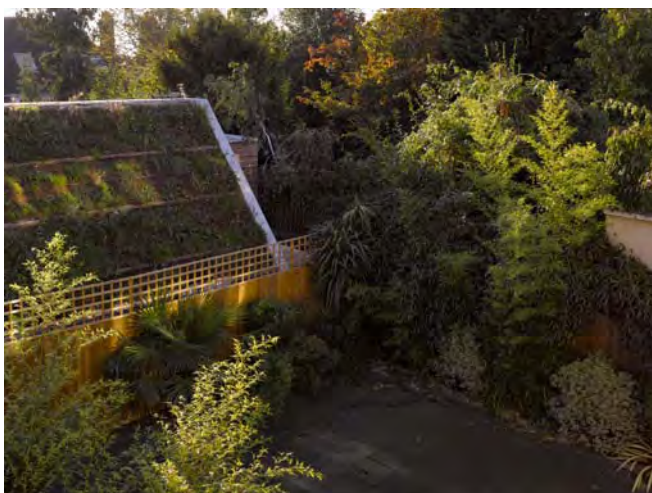
Figure 2-3. Sloping green roof facing neighbour's garden

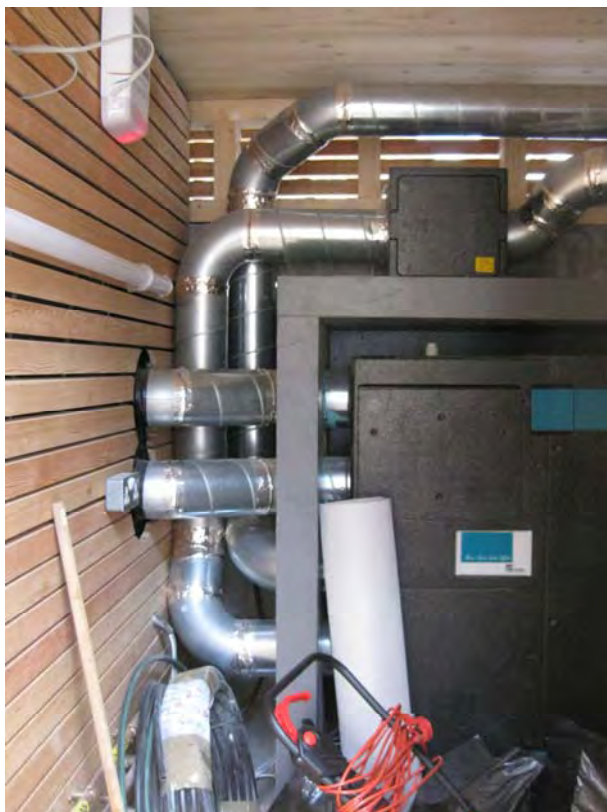
**Figure 2-6. Heat Recovery Ventilation unit (BEFORE DUCTWORK WAS INSULATED) inside the frost-protected unit in the external bike shed.**

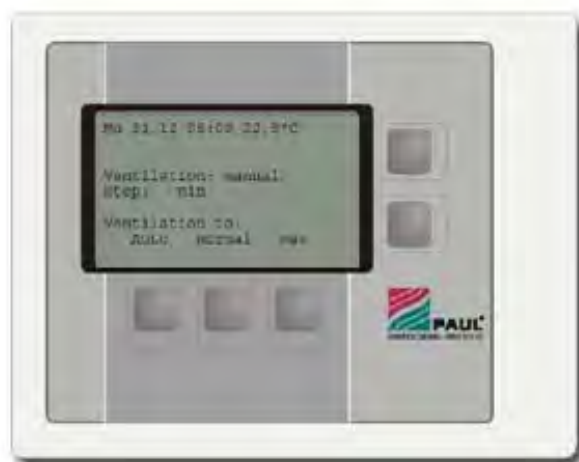
The ventilation speed can be adjusted by the occupants of the house via the main control panel in the living room to any of three settings: 'low', 'normal' and 'party'. Changing the setting is not normally felt to be necessary unless the occupancy level changes for an extended period of a few hours or more. The controls are located in the main living space. Additionally there is a 'boost' button outside the master en-suite bathroom to increase the air change rate for a short period of 15 – 30 minutes. This button could be used to extract excessive moisture from a long shower, but the occupants say they seldom feel the need for it.

Figure 2-7. Ventilation control installed in the living room

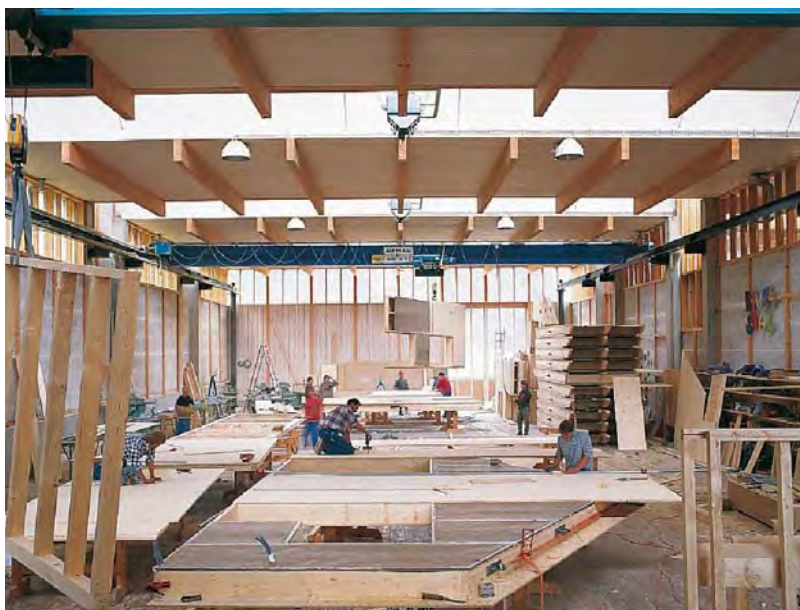
Figure 2-8. The timber frame was prefabricated in Austria by Kaufmann Zimmerei of Reuthe

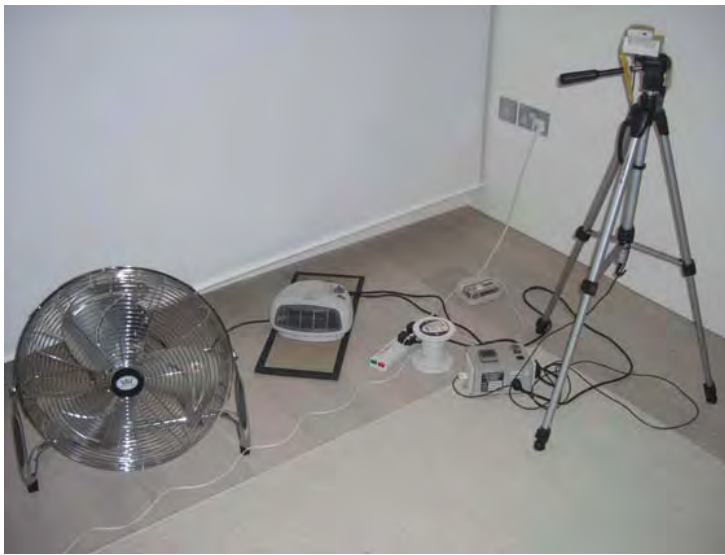
Figure 3-3. Camden Passive House: co-heating test equipment

A second co-heating test was performed by Sam Stamp of University College London between 21<sup>st</sup> - 30<sup>th</sup> December 2012 during Phase 2 of the BPE study (see appendix 6). The weather was cold and overcast throughout the co-heating test and these were considered to be good conditions for the test and much more suitable than the weather conditions during the previous co-heating test reported above.

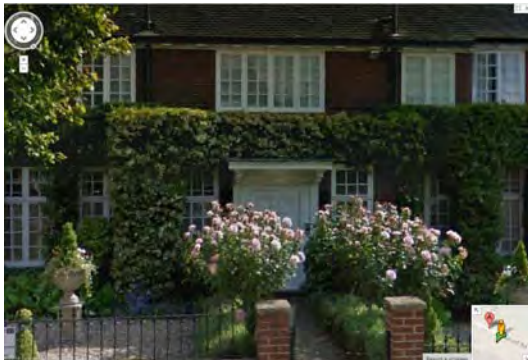
This suggests that parental habits may have been picked up and continued with regard to usage of blinds. The street elevation of the parents' house is north facing so the habit of keeping the blinds closed does not result in loss of sunlight. However at the Camden Passive House, with its South-facing street elevation, closing the street-facing blinds in winter reduces an important source of free energy.

Figure 6-6. Painted timber blinds inside the street-facing windows provide privacy in the parents' family home.
