# **Building Performance Evaluation**

# **Final report**

Phase 2: In-use performance and post occupancy evaluation

Technology Strategy Board BPE ref no:	450069
Project title:	Monitoring of an estate near Rotherham
Lead organisation name:	Verco
Number of properties as part of BPE:	4

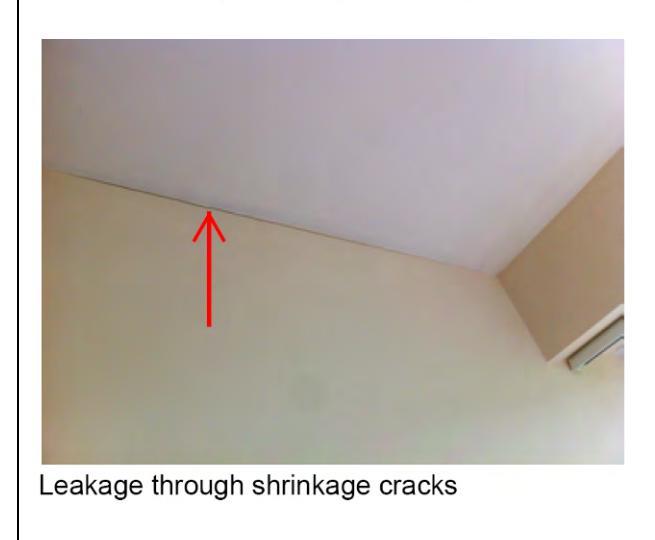
Leakage through floor joints

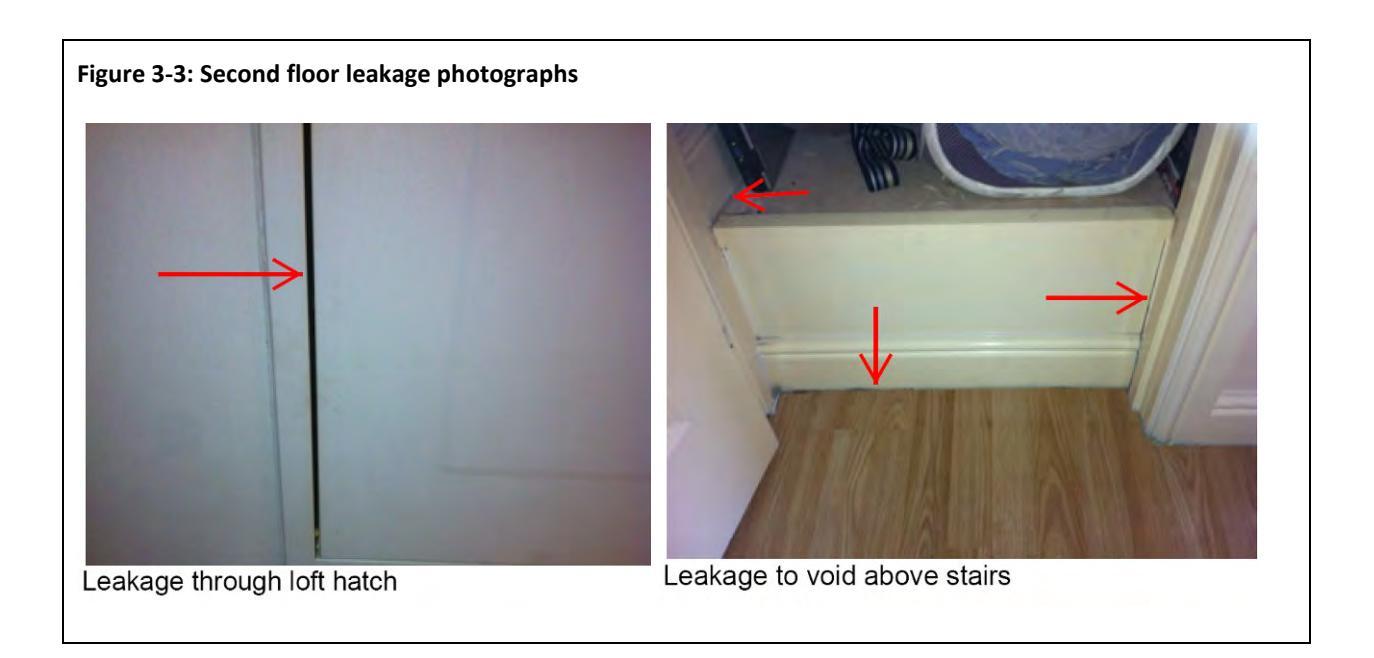
Significant leakage through WC access hatch

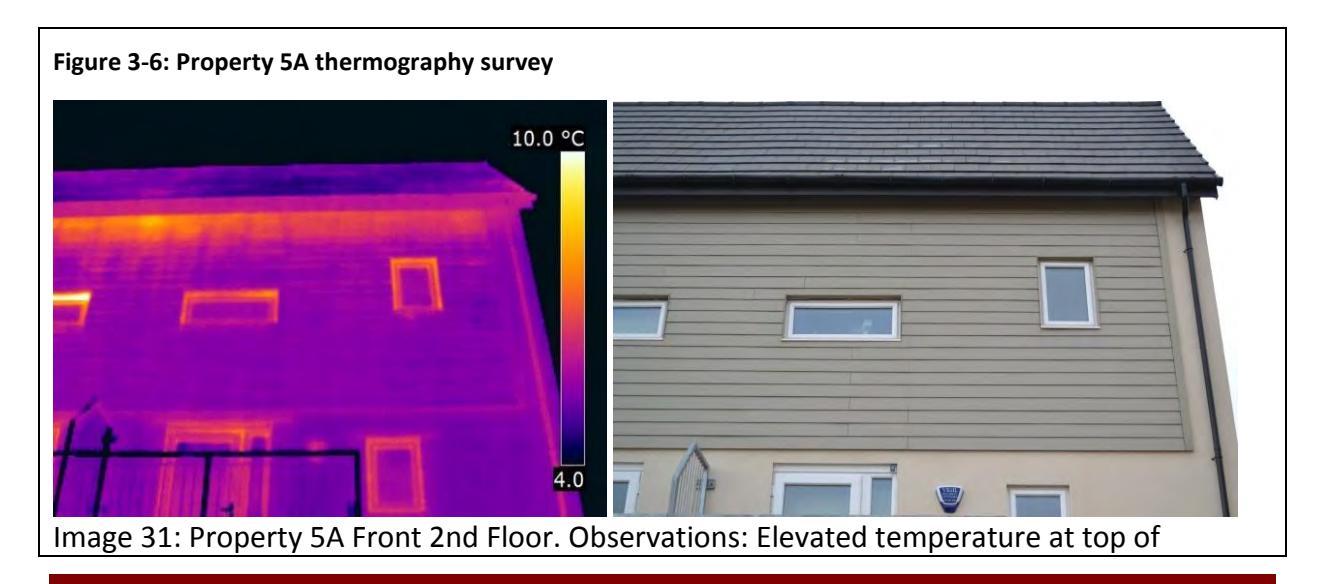
Property 5A (

#### cladding. Note: cladding is ventilated

• ): Anomalous temperature variations were noted through the ventilated cladding in the front of the property

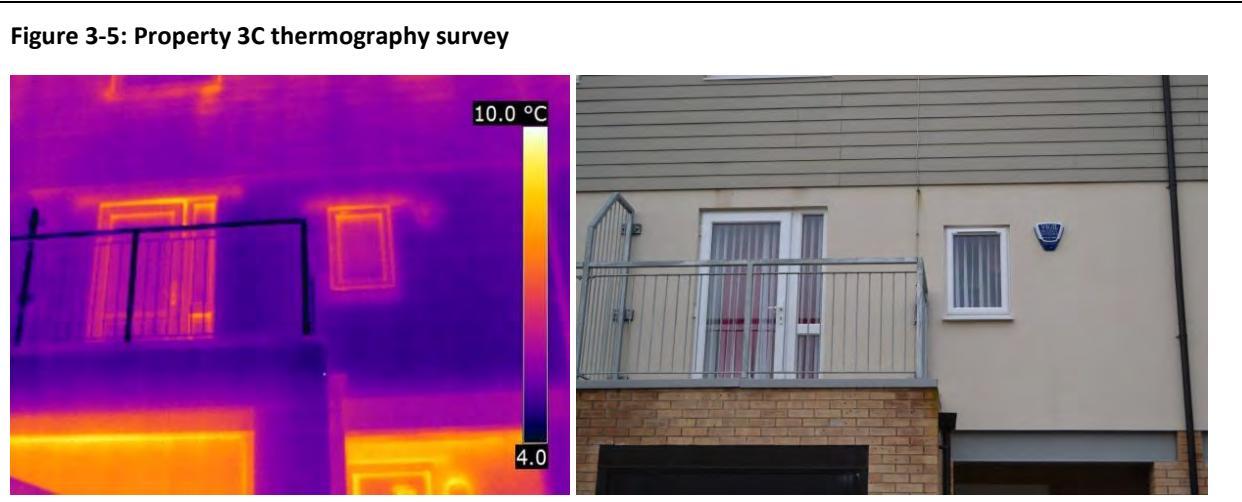
Image 5: Property 3C Front 1st Floor: Observations: Elevated temperatures above windows and door (door had been in use)

Image 5: Property 3C Front 1<sup>st</sup> Floor. Observations: Elevated temperatures above windows and door

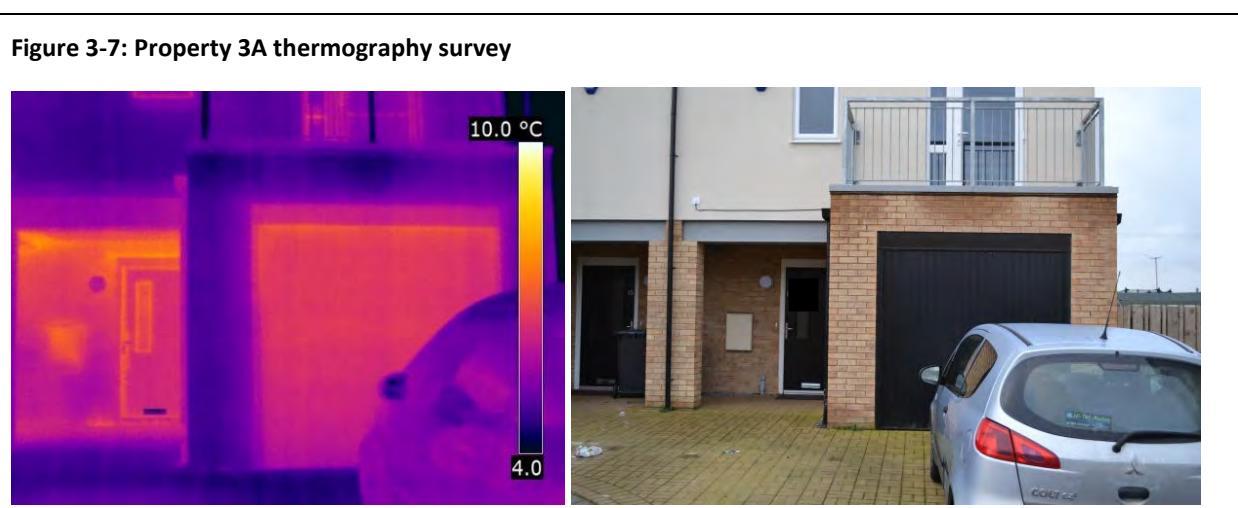
Image 7: Property 3A Front Ground Floor. Observations: Localised temperature elevation at meter box. Porch area temperature elevated, door had been in use.

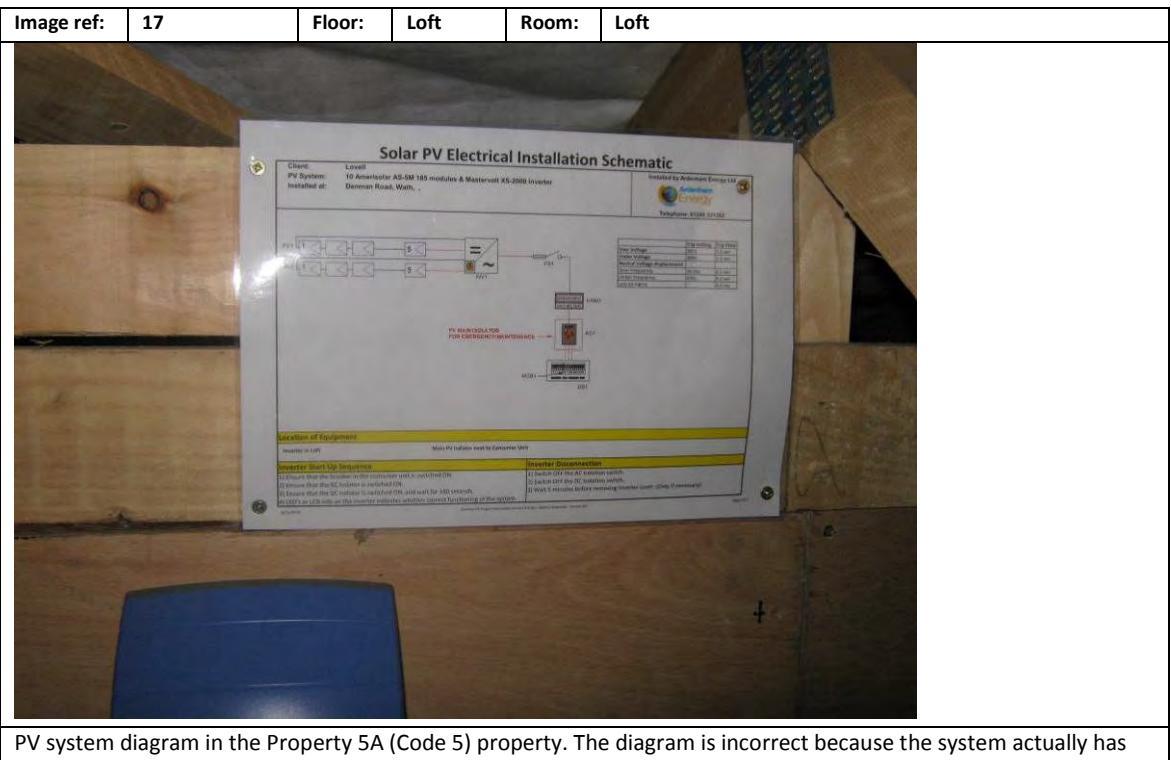
14 PV panels making up 2.6kWp (rather than the 10 panels / 1.85kWpindicated on the diagram) and 3 inverters (rather than 1 as suggested on the diagram).

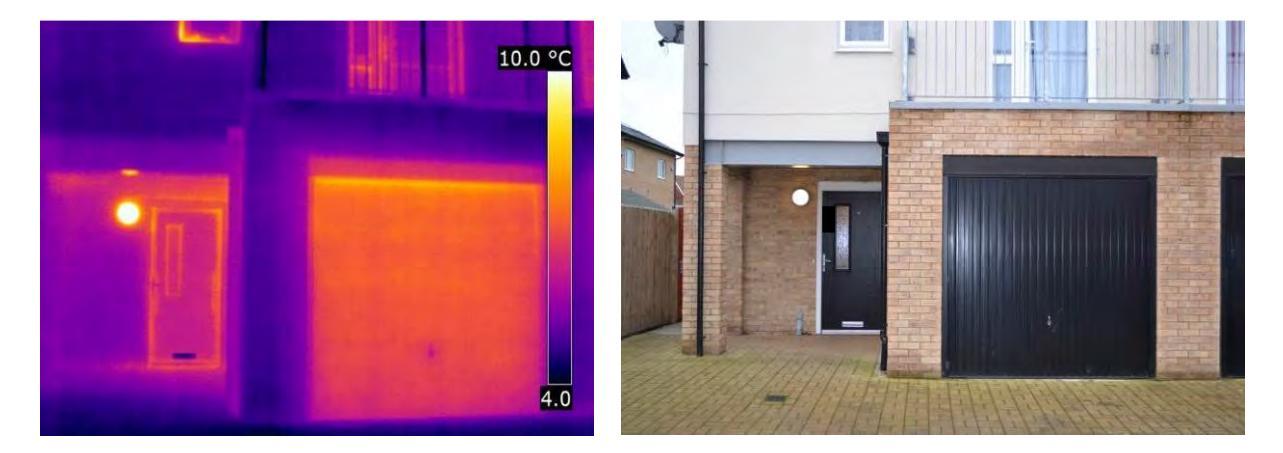
Image 1: Property 3B Front Ground Floor. Observations: Porch area temperature elevated, door had been in use.

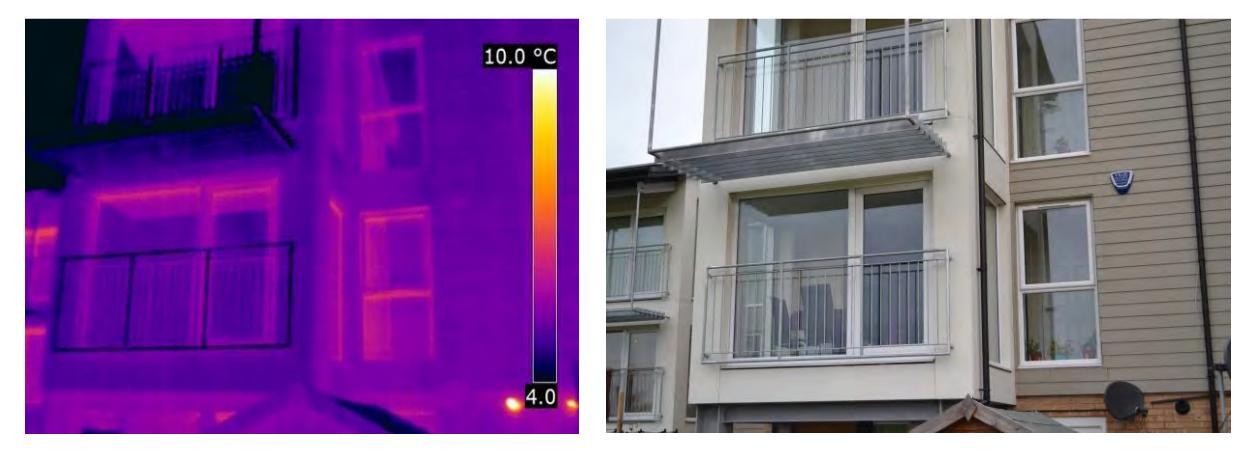
Image 11: Property 3B Rear 1<sup>st</sup> Floor. Observations: No thermal anomalies observed.

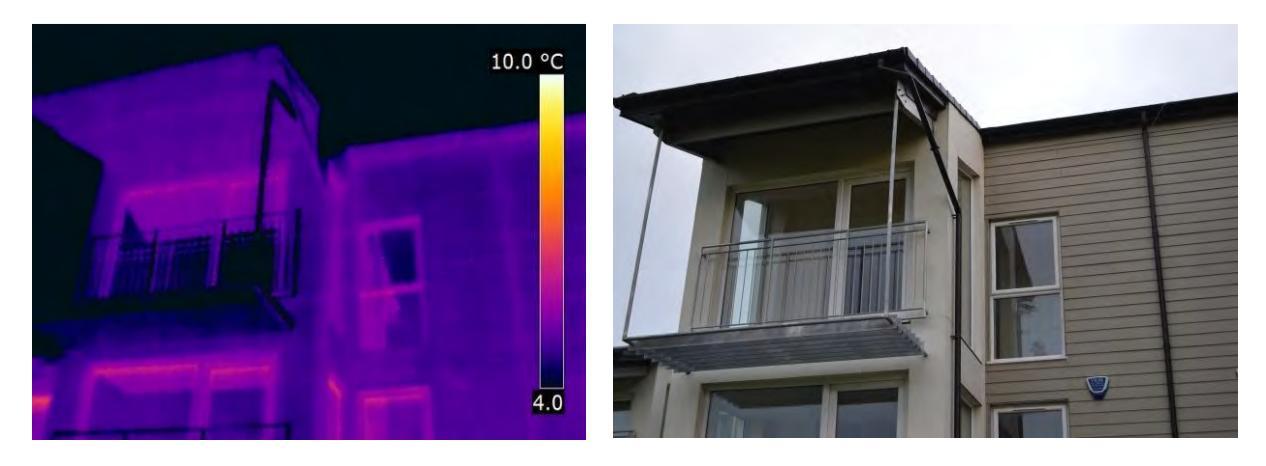
Image 12: Property 3B Rear 2<sup>nd</sup> Floor. Observations: No thermal anomalies observed.

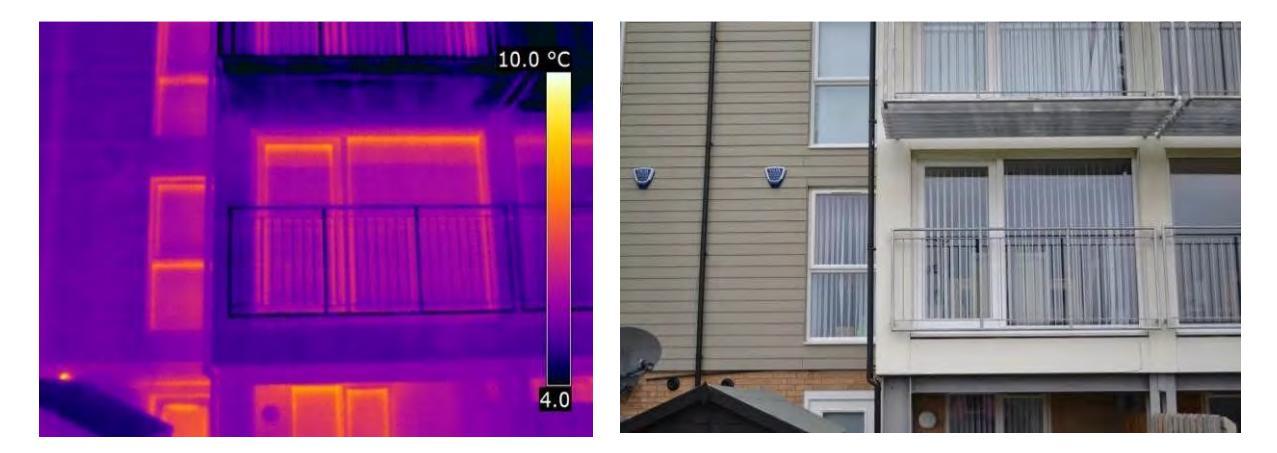
Image 14: Property 3C Rear 1<sup>st</sup> Floor. Observations: No thermal anomalies observed.

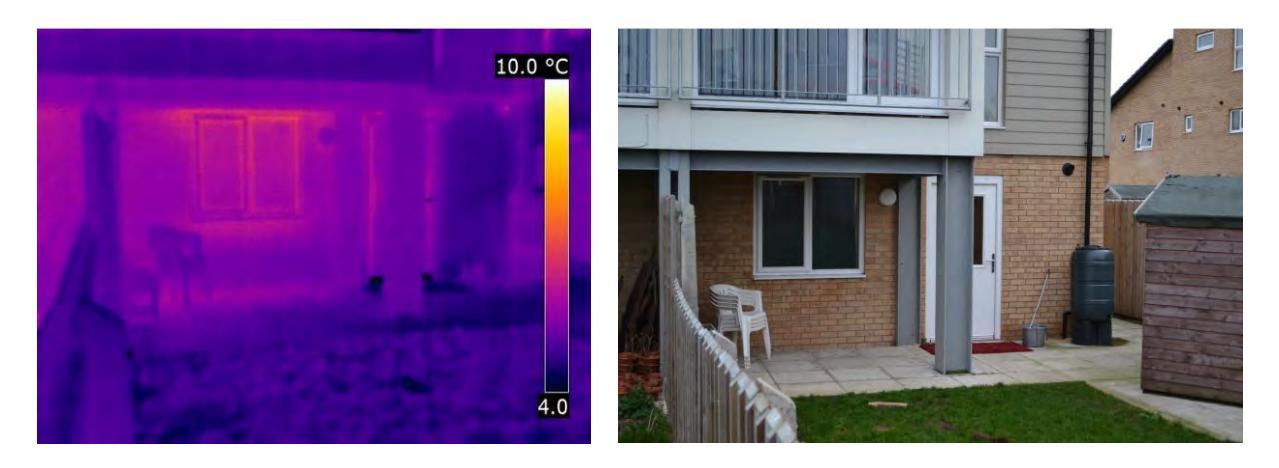
Image 16: Property 3A Rear Ground Floor. Observations: Minimal localised temperature elevation above and below window

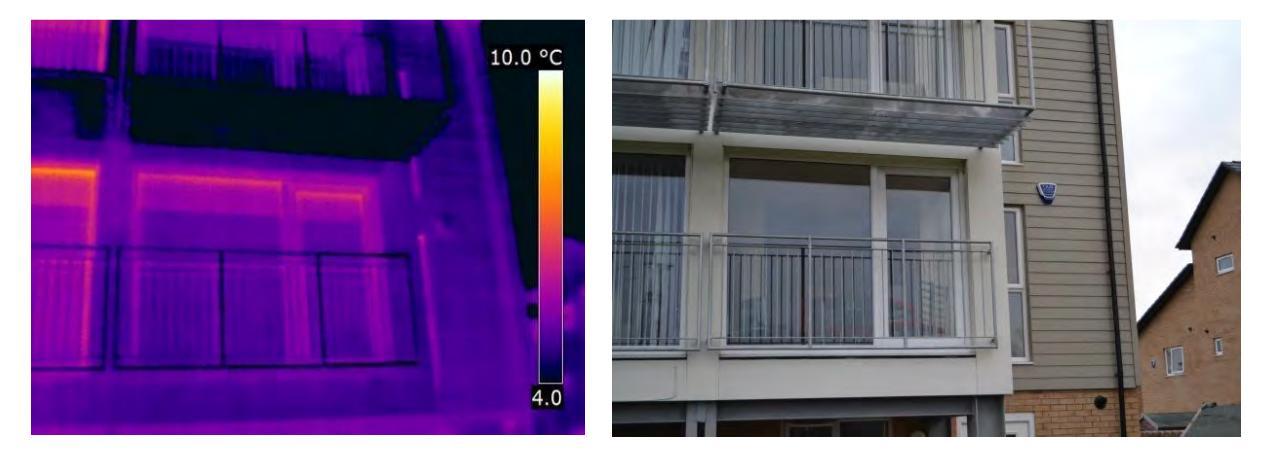
Image 17: Property 3A Rear 1<sup>st</sup> Floor. Observations: No thermal anomalies observed.

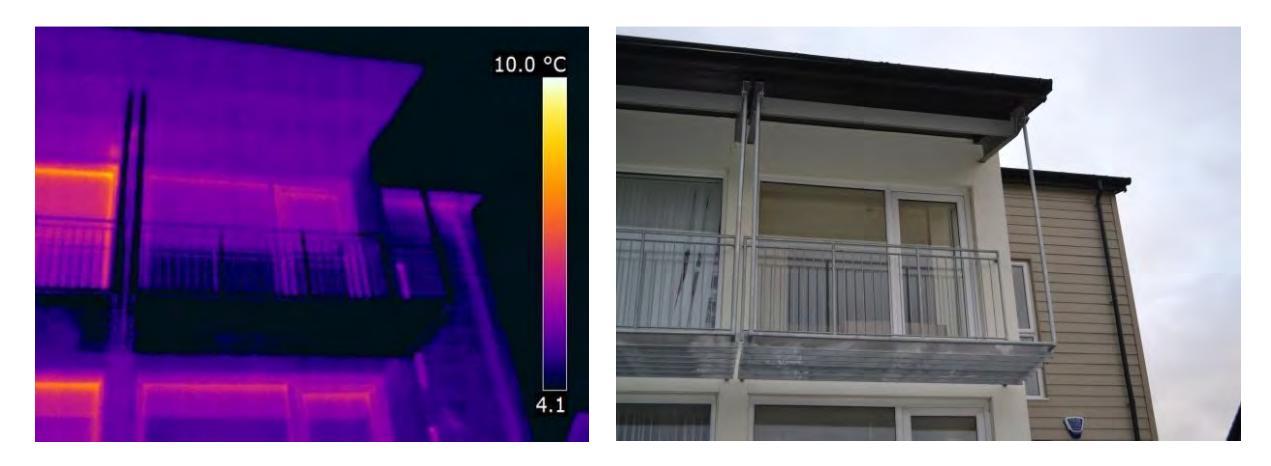
Image 18: Property 3A Rear 2<sup>nd</sup> Floor. Observations: No thermal anomalies observed.

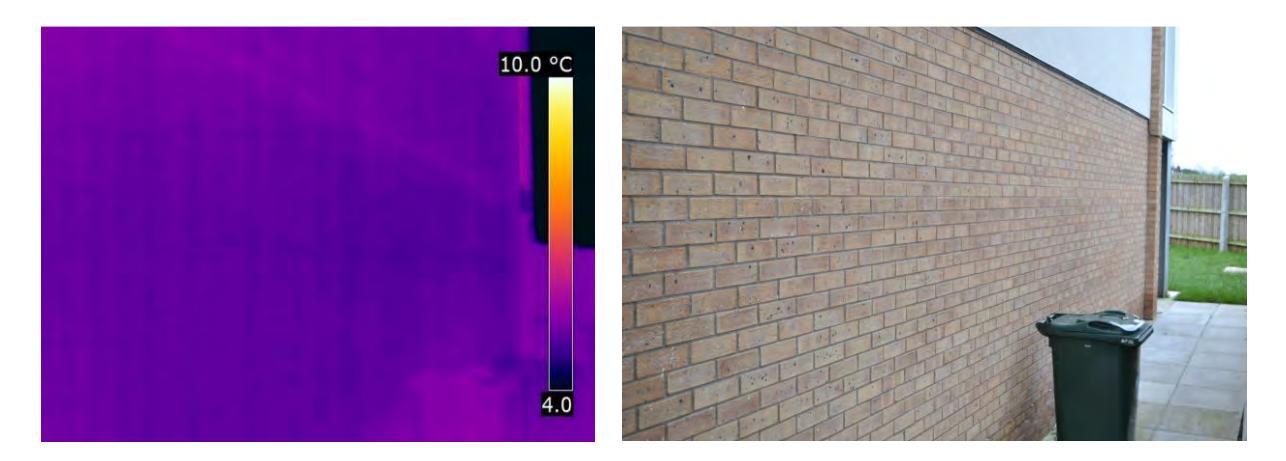
Image 19: Property 3A Side Ground Floor. Observations: No thermal anomalies observed.

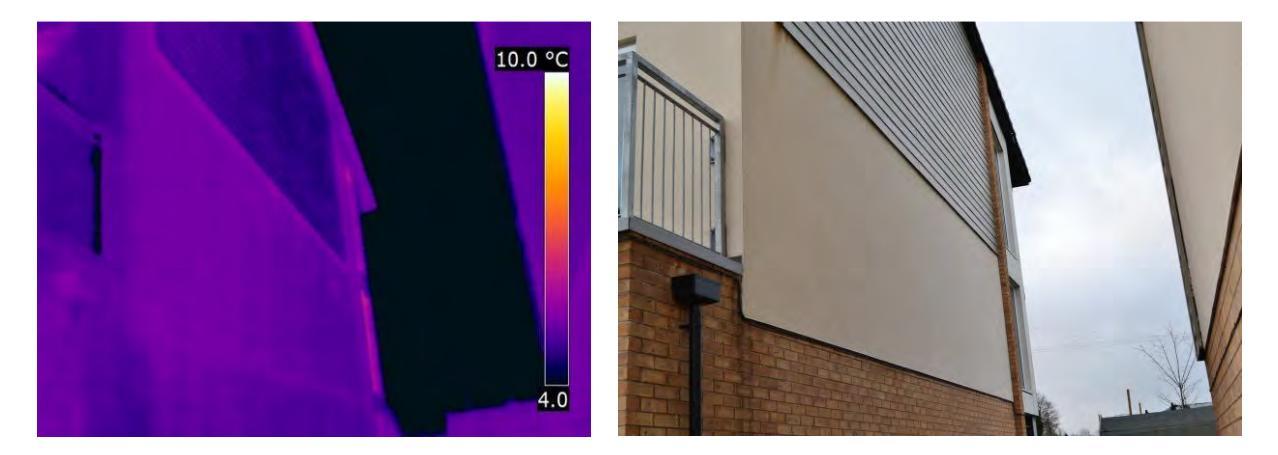
Image 20: Property 3A Side 1<sup>st</sup> Floor. Observations: No thermal anomalies observed.

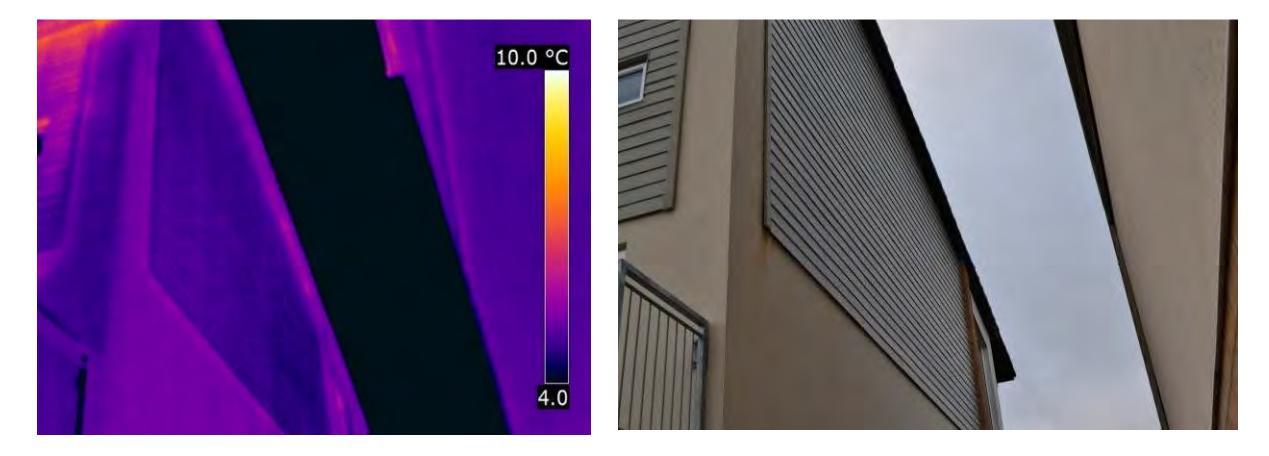
Image 21: Property 3A Side 2<sup>nd</sup> Floor. Observations: No thermal anomalies observed.

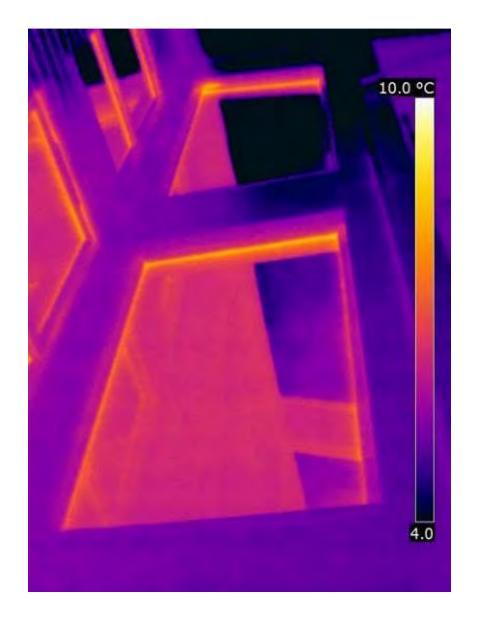
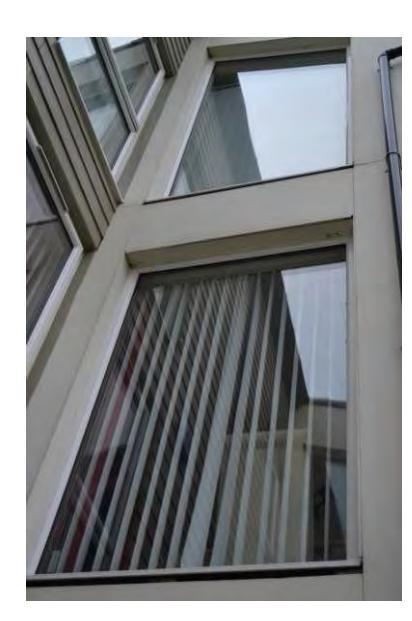
Image 22: Property 3C Rear Side Bay. Observations: No thermal anomalies observed; temperature variations due to reflection.

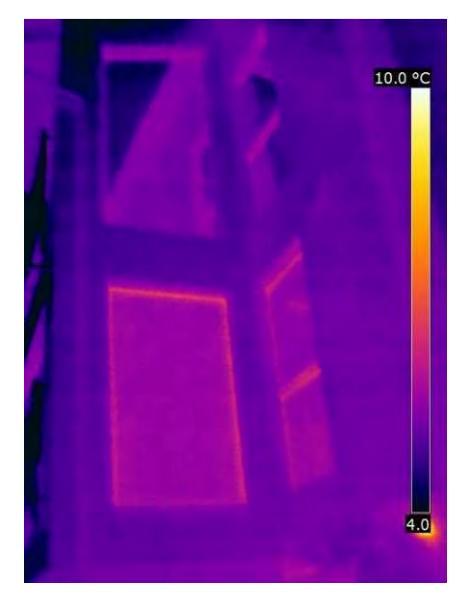
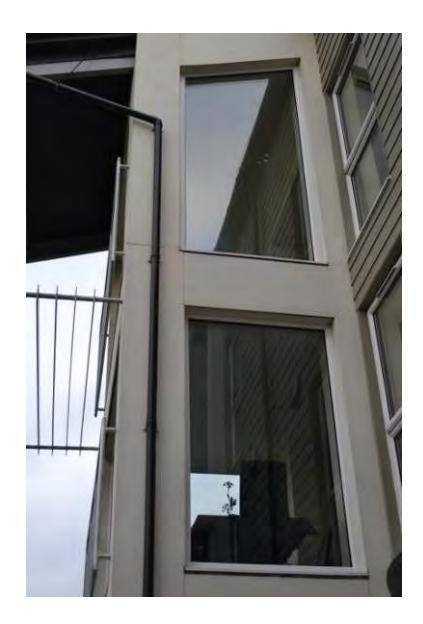
Image 23: Property 3A Rear Side Bay. Observations: No thermal anomalies observed; temperature variations due to reflection.

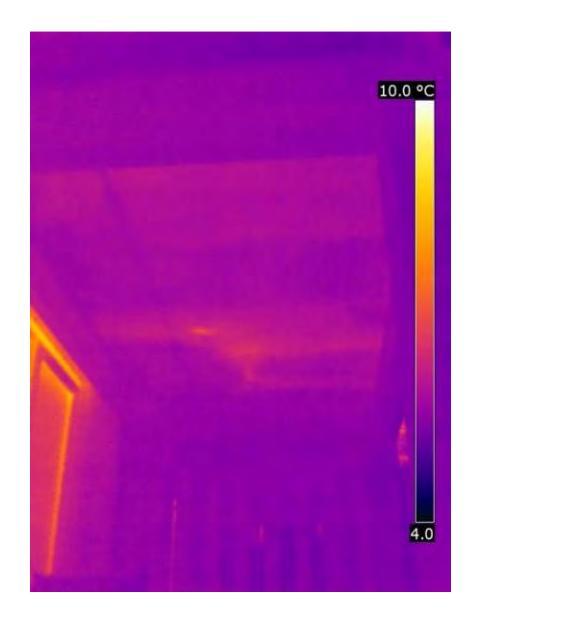
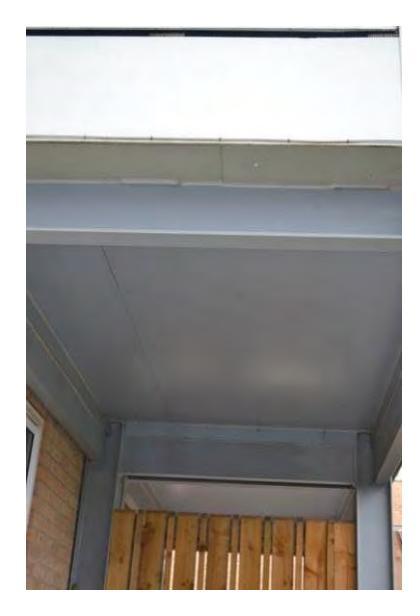
Image 25: Property 3C Rear Bay (Underside). Observations: Small anomaly at centre of panel

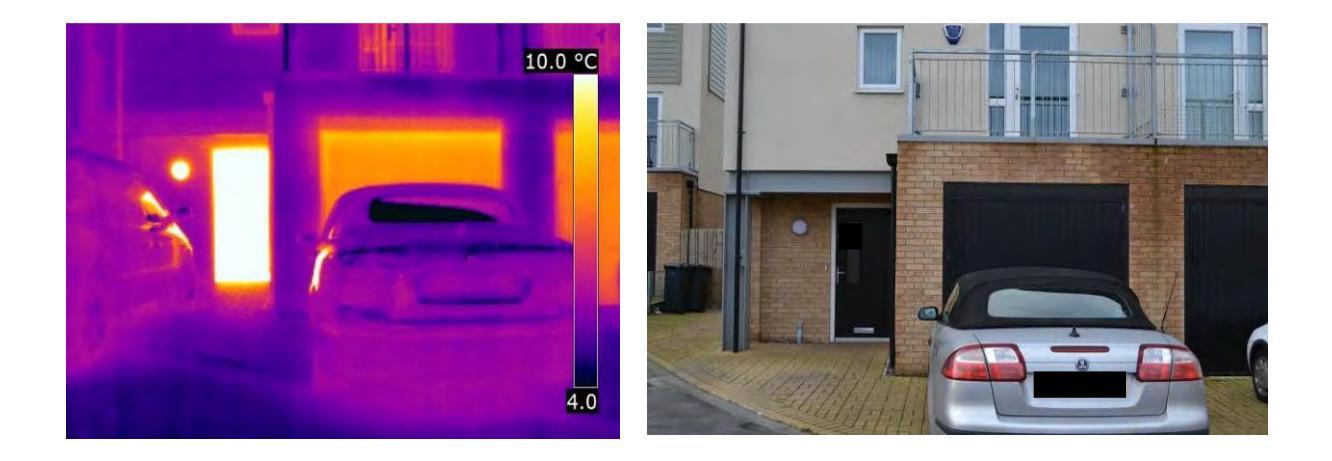
Image 26: Property 5B Front Ground Floor. Observations: Elevated door temperature, recently in use prior to survey.

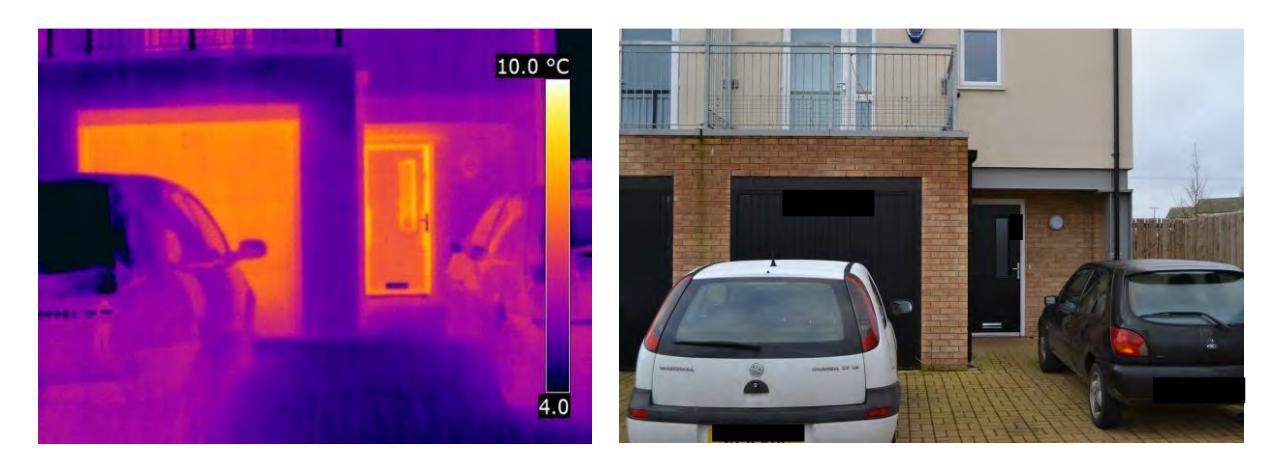
Image 29: Property 5A Front Ground Floor. Observations: Localised temperature elevation around door. Door had been in use.

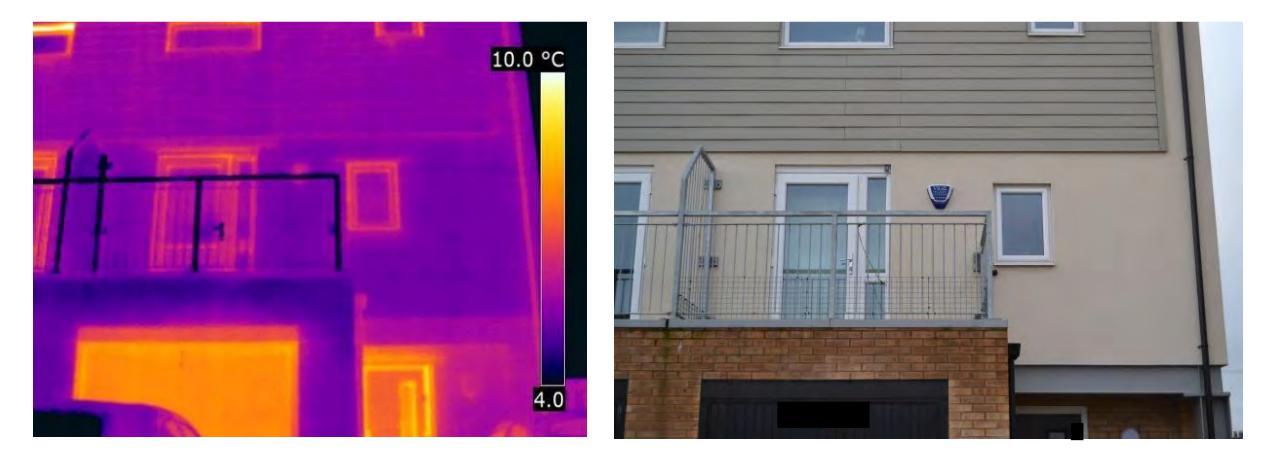
Image 30: Property 5A Front 1st Floor. Observations: No thermal anomalies observed

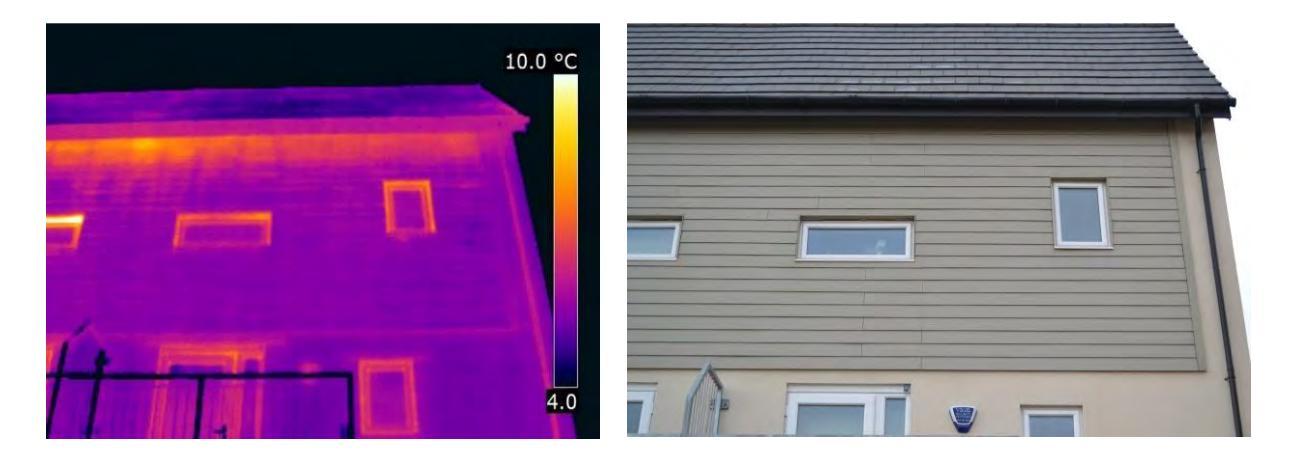
Image 31: Property 5A Front 2nd Floor. Observations: Elevated temperature at top of cladding. Note: cladding is ventilated

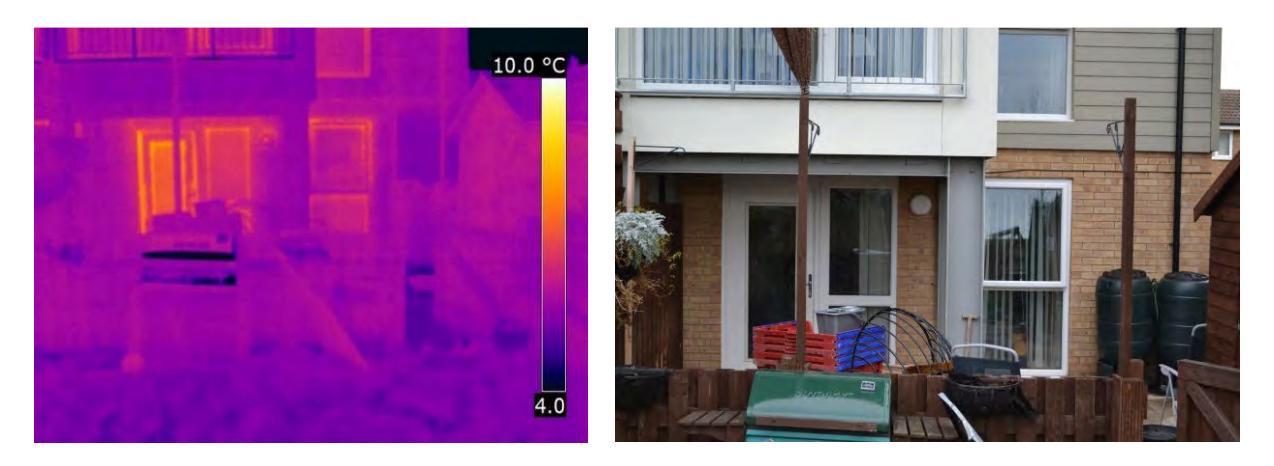
Image 32: Property 5B Rear Ground Floor. Observations: No thermal anomalies observed

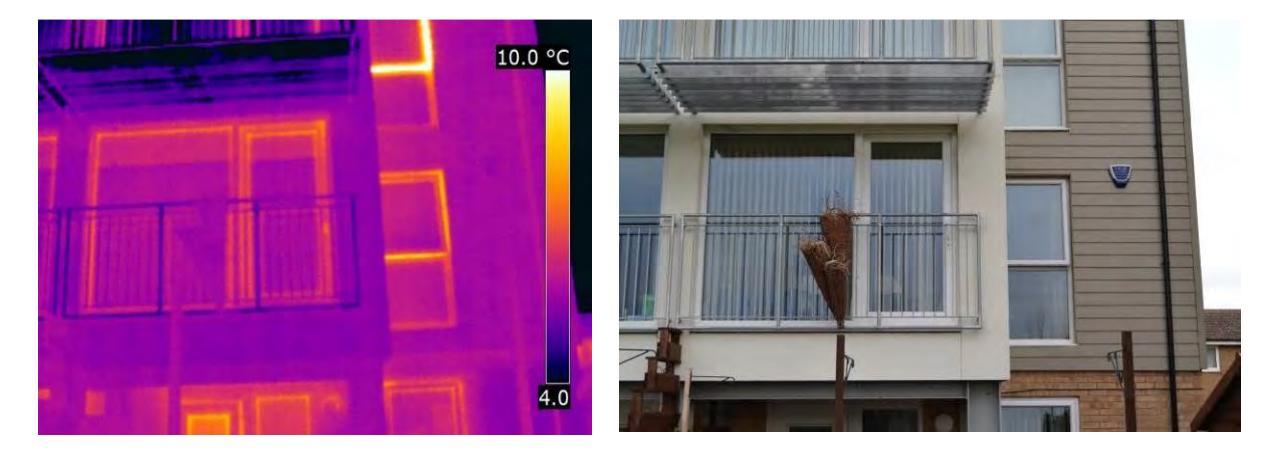
Image 33: Property 5B Rear 1st Floor. Observations: right hand windows partially open no other thermal anomalies observed

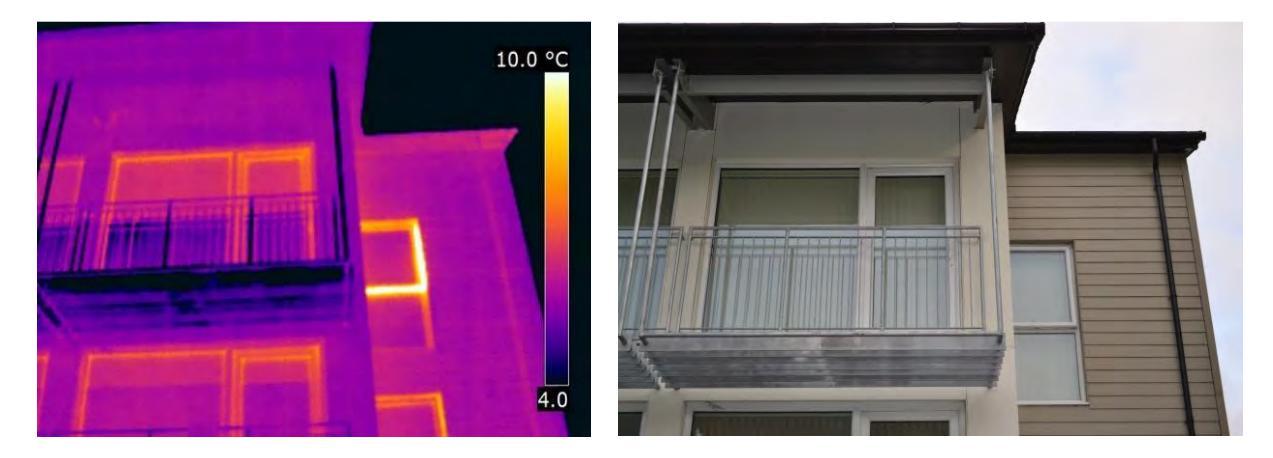
Image 34: Property 5B Rear 2nd Floor. Observations: Right hand window open causing localised heating no other thermal anomalies observed

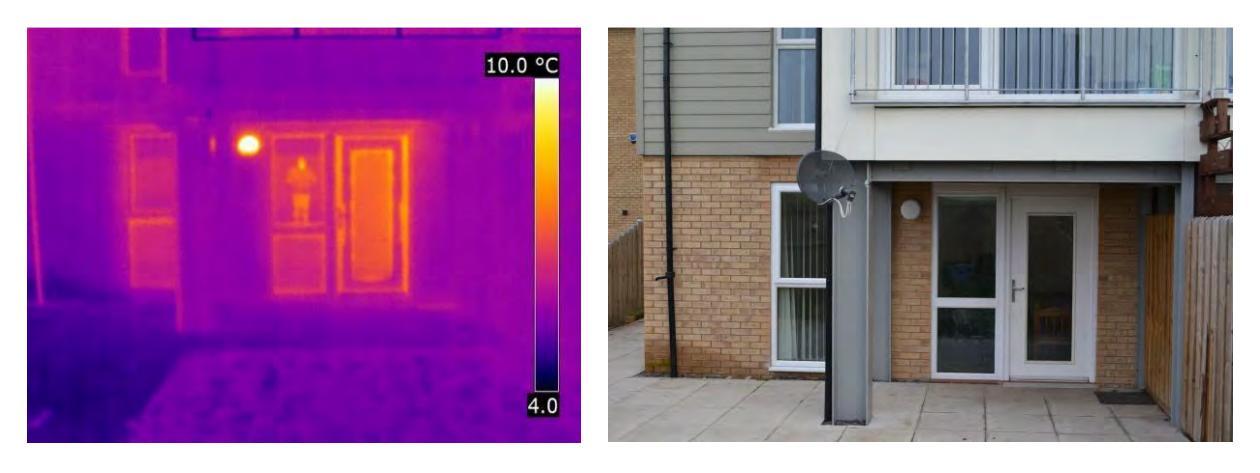
Image 35: Property 5A Rear Ground Floor. Observations: No thermal anomalies observed

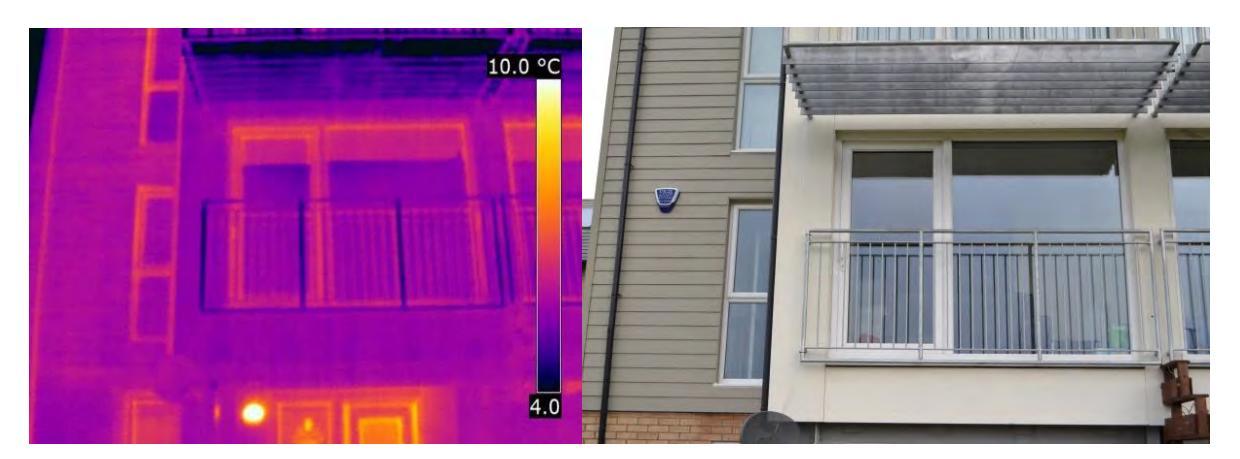
Image 36: Property 5A Rear 1st Floor. Observations: No thermal anomalies observed

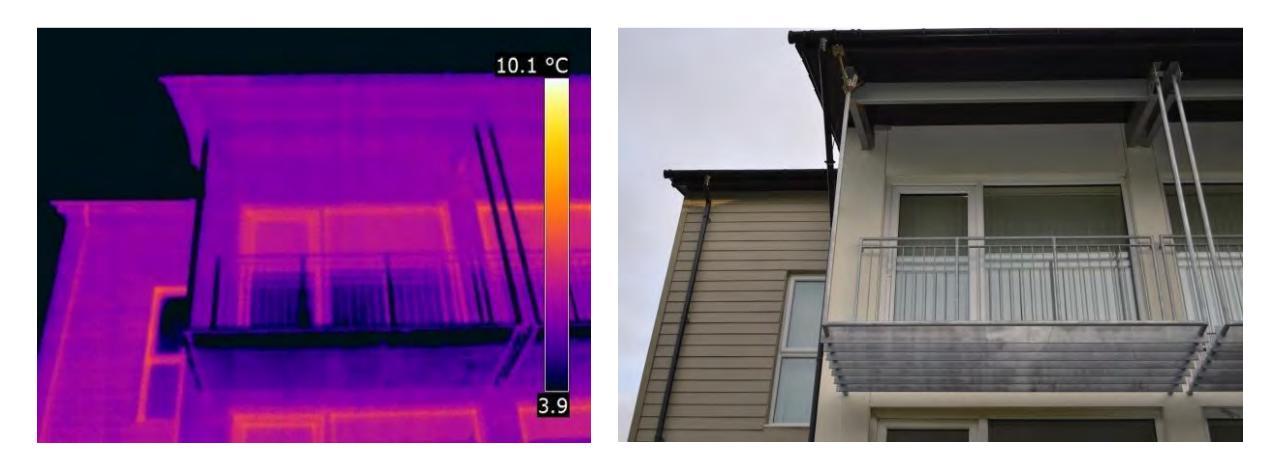
Image 37: Property 5A Rear 2nd Floor. Observations: No thermal anomalies observed

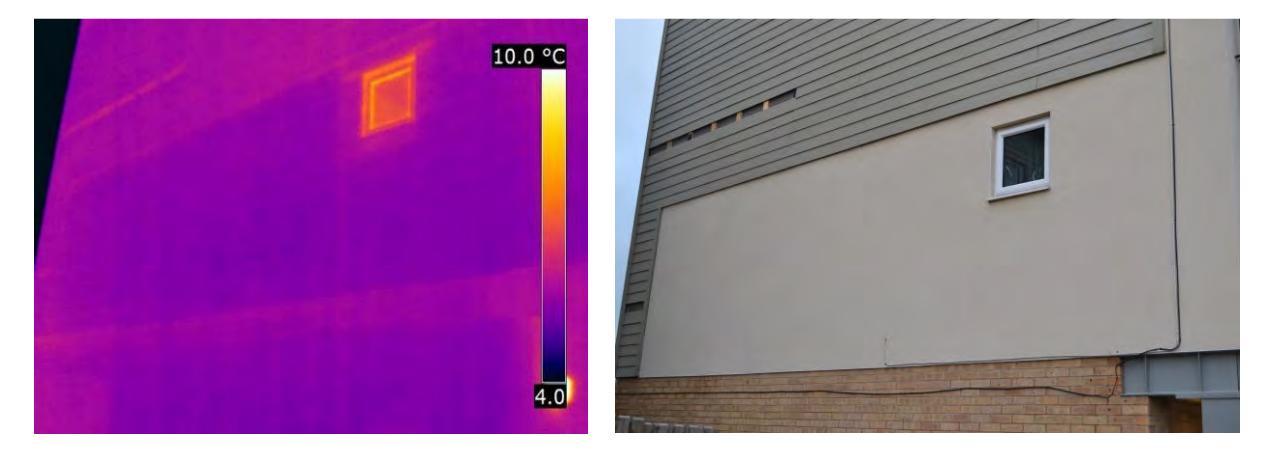
Image 39: Property 5B Side 1st Floor. Observations: No thermal anomalies observed

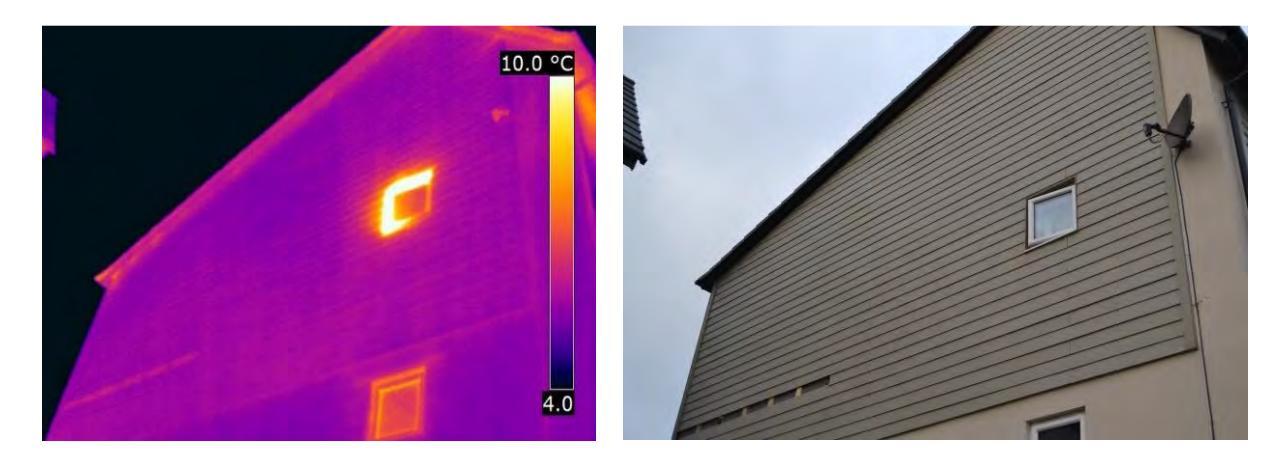
Image 40: Property 5B Side 2nd Floor. Observations: No thermal anomalies observed. Localised heating at window as open.

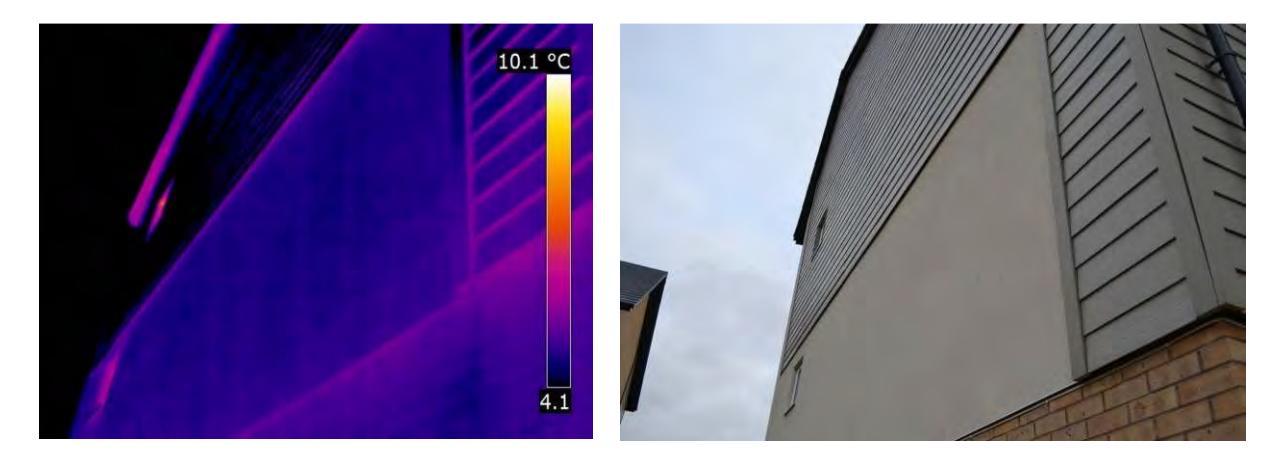
Image 41: Property 5A Side 1<sup>st</sup> & 2nd Floor. Observations: No thermal anomalies observed

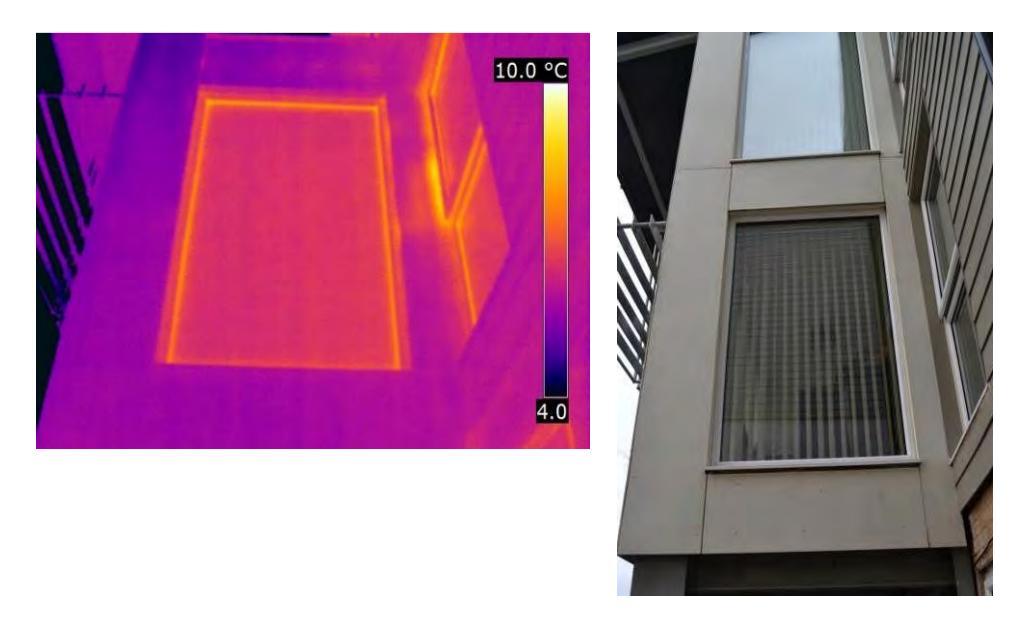
Image 42: Property 5B Rear Side Bay (1<sup>st</sup>). Observations: No thermal anomalies observed, temperature variation due to reflection

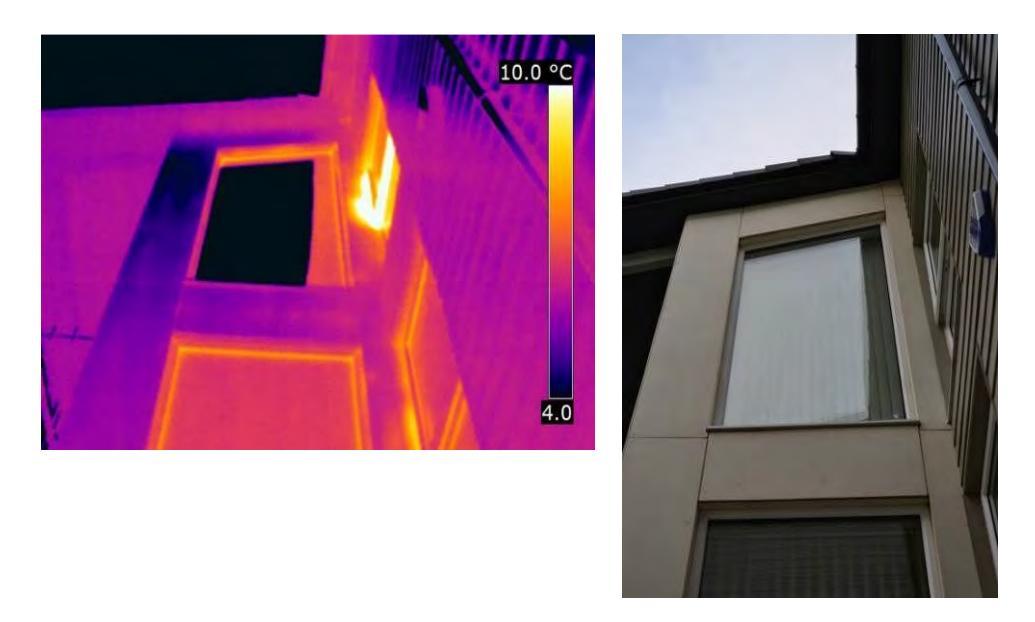
Image 43: Property 5B Rear Side Bay (2<sup>nd</sup>). Observations: No thermal anomalies observed; temperature variation due to reflection.

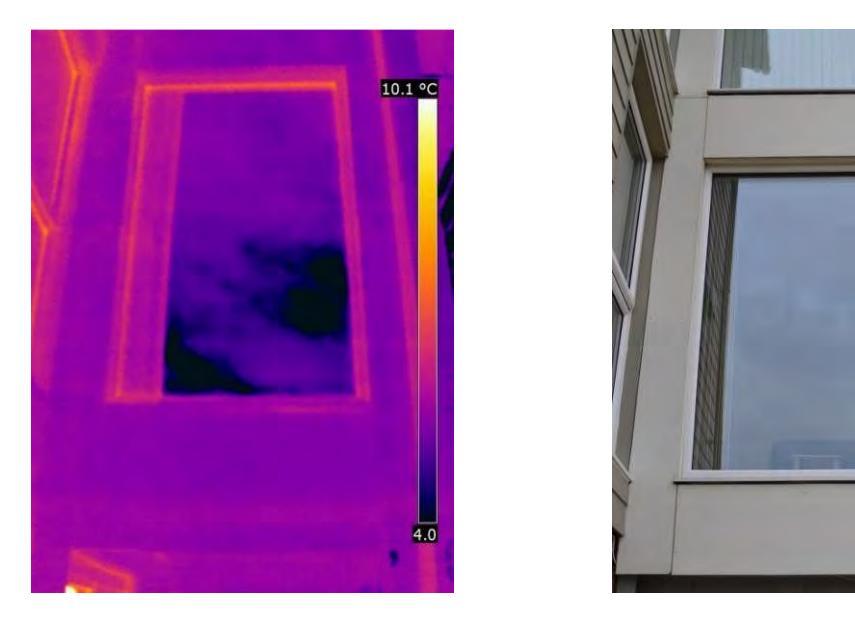
Image 44: Property 5A Rear Side Bay (1<sup>st</sup>). Observations: No thermal anomalies observed

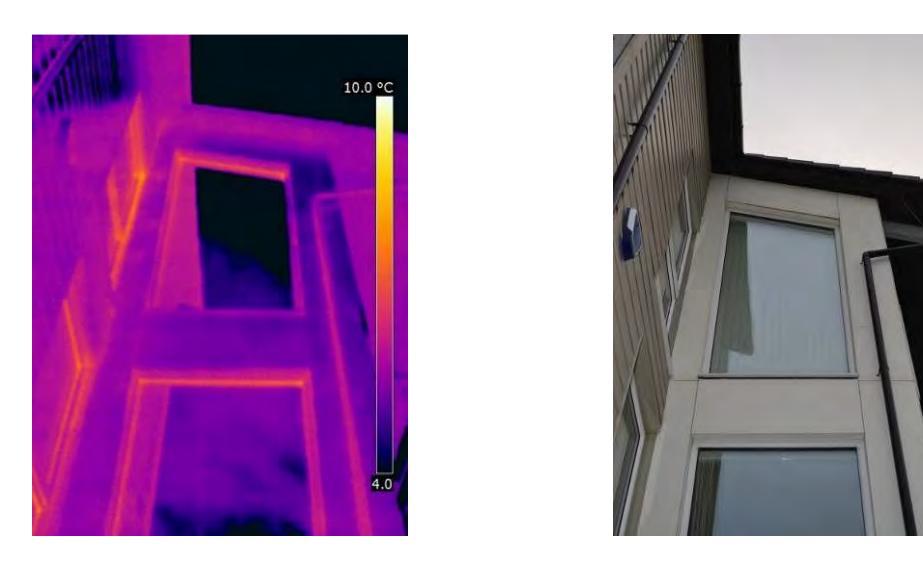
Image 45: Property 5A Rear Side Bay (2<sup>nd</sup>). Observations: No thermal anomalies observed; temperature variations due to reflection.
