# **Building Performance Evaluation**

# **Final report**

Phase 2: In-use performance and post occupancy evaluation

Technology Strategy Board BPE ref no:	450069
Project title:	Monitoring of an estate near Rotherham
Lead organisation name:	Verco
Number of properties as part of BPE:	4

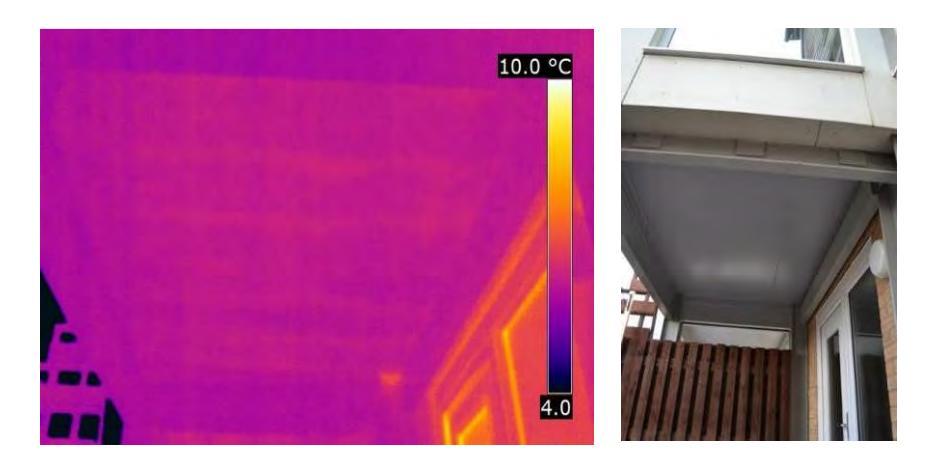
Image 46: Property 5B Rear Bay (Underside). Observations: No thermal anomalies observed

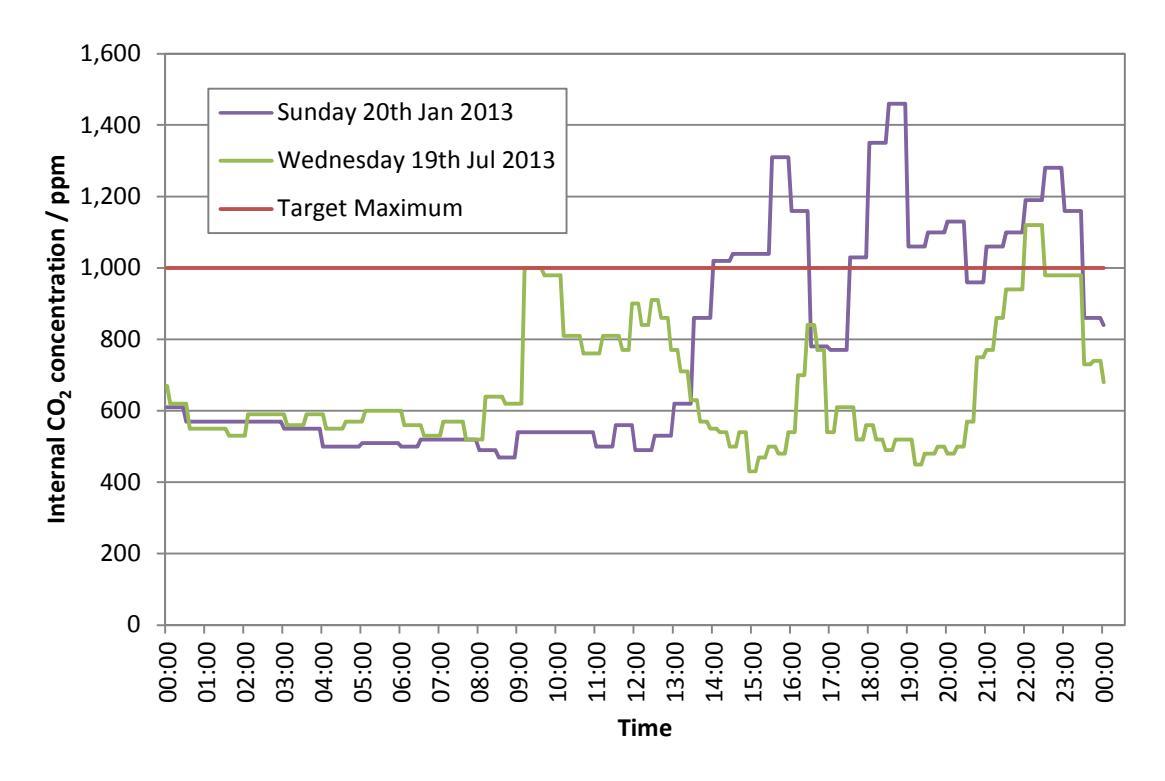
#### Figure 0-4: Internal CO<sub>2</sub> concentration of Property 3A

The profile of CO<sub>2</sub> concentration in this property looks to be within acceptable margins, however the tenant's lack of understanding of the MVHR boost controls may be contributing to the peaks in the afternoon.

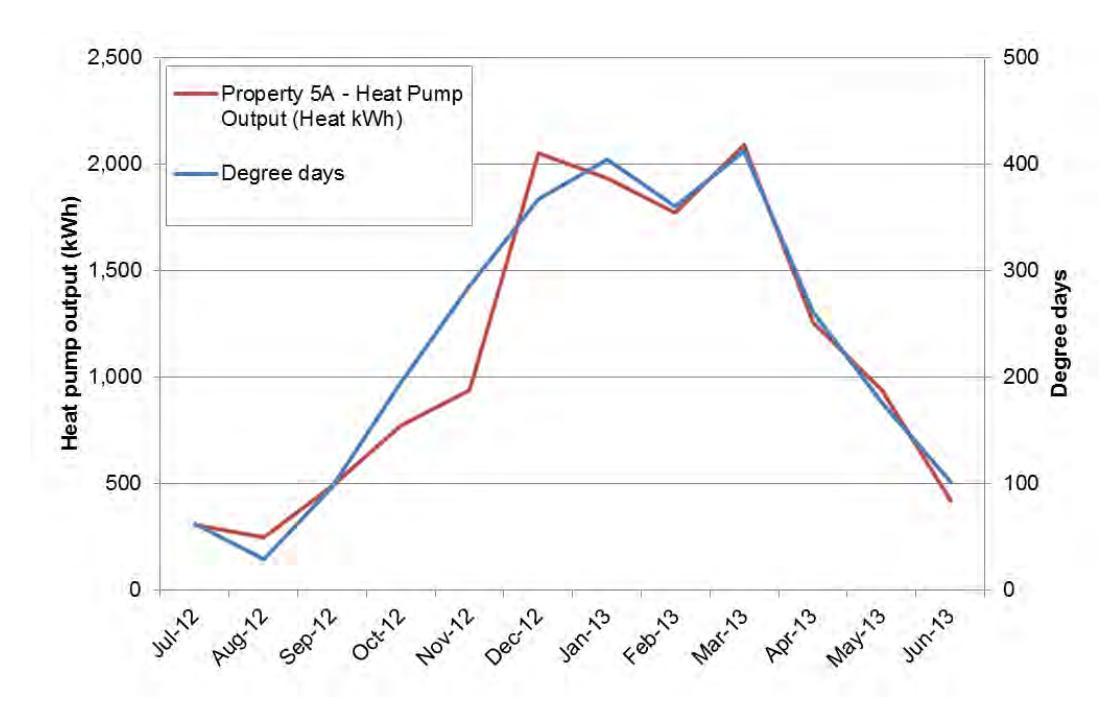
#### Figure 0-7: Heat pump output compared to degree days

Figure 0-7 shows that there is a very strong relationship between the degree days (to base 15.5°c) and the heat demand of the property. Given the well-insulated nature of the property, we would expect the heating season to be shortened and the heating demand to fit the profile of degree days to a lower base temperature (an extreme example is the Passivhaus concept which results very little heating demand and a very short heating season). However, the heat demand is much higher than predicted by SAP, due to the high internal temperatures. This is offsetting the impact of the high insulation levels, and leaves the house with a "typical" heating profile.

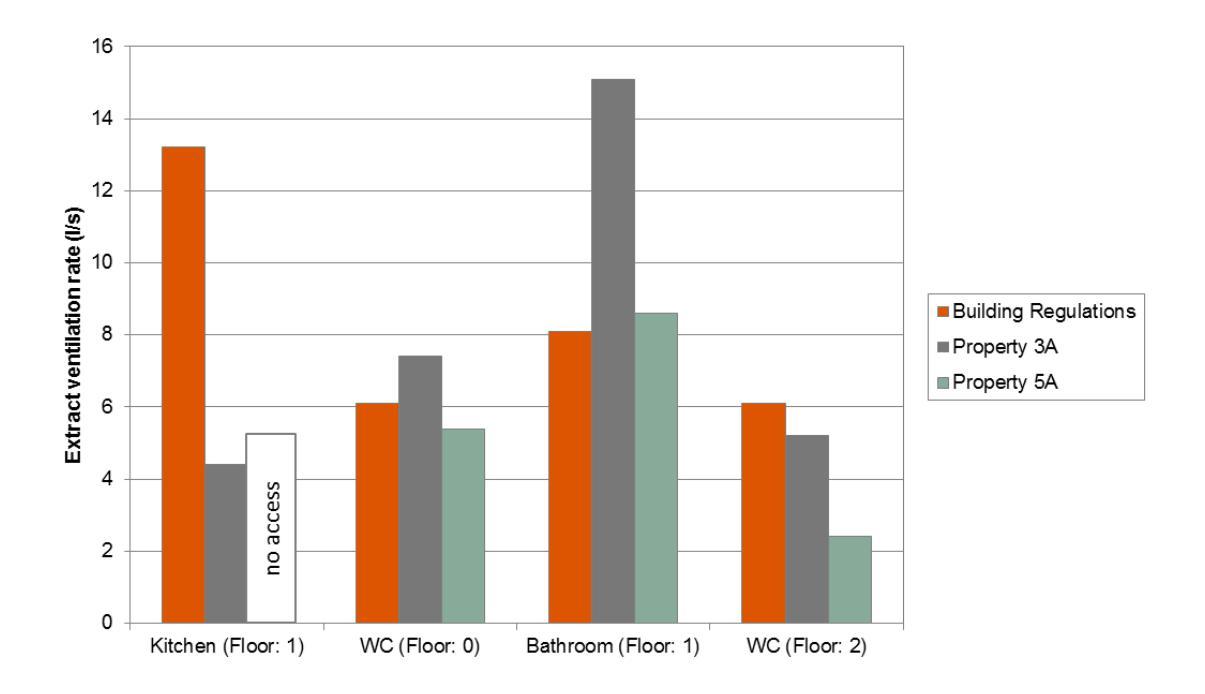
- On closer inspection, the supply & extract rates to individual rooms showed a wide variation from substantial over-ventilation to severe under-ventilation. (See Figure 0-8 and Figure 0-9 in section 14.5.2 of the appendix for further detail) It should be noted that under-ventilation can lead to mould formation, so a solution should be implemented by TGP.

The measured flow rates have been compared with the design flow rates for each room, see Figure 0-8 and Figure 0-9 in section 14.5.2 of the appendix. It appears that the rooms receive very varied ventilation rates: some are significantly under-ventilated, some are adequately ventilated, and one room is significantly over-ventilated. If all the rooms in a property were under-ventilated to a similar degree, this might raise concerns with the excess ducting in the loft, or fan underperformance in the unit itself. However, since the results are so varied, it is more likely that the units were not commissioned to match the building regulations calculation, there is excess resistance in specific air pathways, or that there has been tenant interference with the duct settings (it was noted during testing that the ducts were not locked off).
